JOINT INVESTIGATION REPORT

INCIDENT NO: 2624644 JIV report S/N: 0552

1. Fountain Incident Number: 2624644 2. Type of incident* OIL SPILL
3. Name of Location 10" DIEBU CREEK - NYN RIVER PIPELINE
4. Name of nearest community OSOKAMA (OPOROMA) 5. State: BAYELSA 6. LGA SOUTHERN IJAW
7. Production Facility/Installation OIL PIPELINE
8. Asset Owner/Hub THE SHELL PETROLEUM DEVELOPMENT COMPANY OF NIGERIA LIMITED (SPDC) / PIPELINE

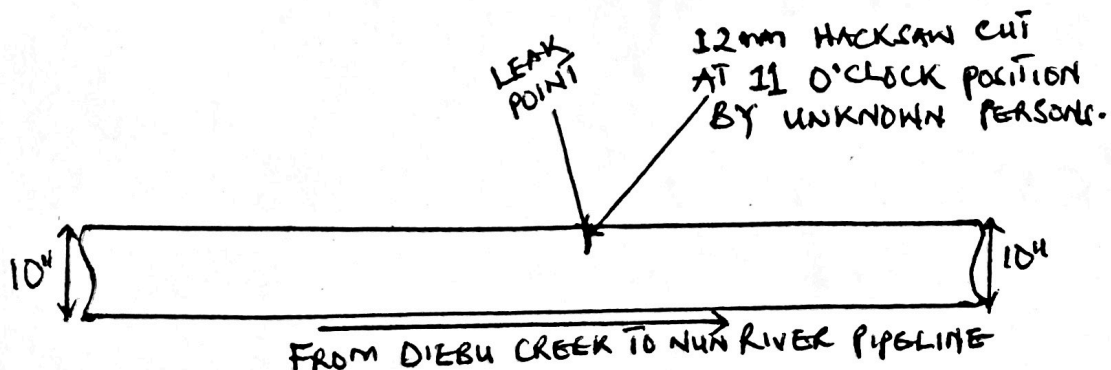
| <input type="checkbox"/> Smooth round-edge hole | <input type="checkbox"/> Rough-edge hole | <input checked="" type="checkbox"/> Hack saw cut |

- Third party interference (Sabotage ; crude theft ; Line theft ; Accidental 3rd party damage
 Operational Others (including Mystery spills) _____

E. GRAPHIC DESCRIPTION OF LEAK POINT (while detailed description of the leak point should be contained in the leak report, overview sketch of the site should be added as appendix 1) A SECTION OF 10" DIEBU-CREEK - NUN RIVER PIPELINE AT DSOKAMA (OPOROMA) SHOWING A 12mm HACKSAW CUT AT 11 O'CLOCK POSITION BY UNKNOWN PERSONS.
