# JOINT INVESTIGATION REPORT

INCIDENT NO: 2625819 JIV report S/N: 0501

1. Fountain Incident Number: 2625819 2. Type of incident\* OIL SPILL  
3. Name of Location 18" ASSA - RUMUKEPE PIPELINE  
4. Name of nearest community OCHIA 5. State: IMO 6. LGA OHAJI EGBEMA  
7. Production Facility/Installation OIL PIPELINE  
8. Asset Owner/Hub THE SHELL PETROLEUM DEVELOPMENT COMPANY  
B. INCIDENT INFORMATION: OF NIGERIA LIMITED / PIPELINE

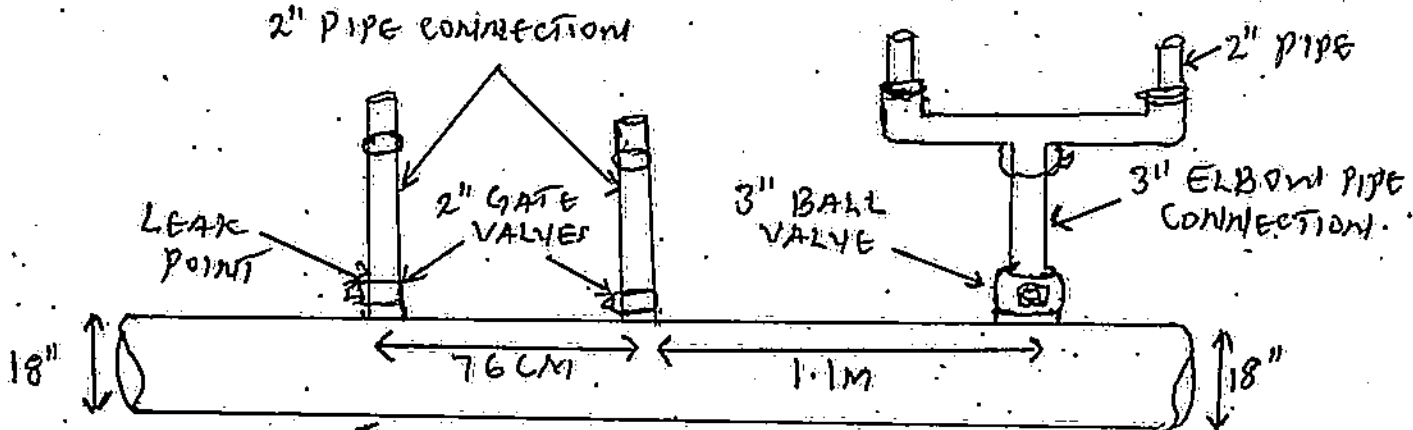
SAND BAGS AND FLEXIBLE HOSES WERE OBSERVED.

| <input checked="" type="checkbox"/> Failed Weld-on illegal hot tap valve | <input type="checkbox"/> Failed Clamp, | <input type="checkbox"/> Missing Pipeline/Flowline |
| <input checked="" type="checkbox"/> Crude oil theft (illegal bunkering) point, | <input type="checkbox"/> Saver-pit over flow | <input type="checkbox"/> Third party tampering with Clamp |

SECTION OF 18" ASSA - RUMMEKPE PIPELINE AT BETHA  
SHOWING 3 NOS OF CRUDE OIL TIGHT POINTS AT 12 O'CLOCK POSITION

RECOVERY ACTIVITIES AND REPAIR WORK ARE ONGOING.
