Overview: Part of spill impact on 20" Kolocreek – Rumuekpe Pipeline at Odau KM10. Picture was taken during Joint Investigation of 10<sup>th</sup> April 2020.

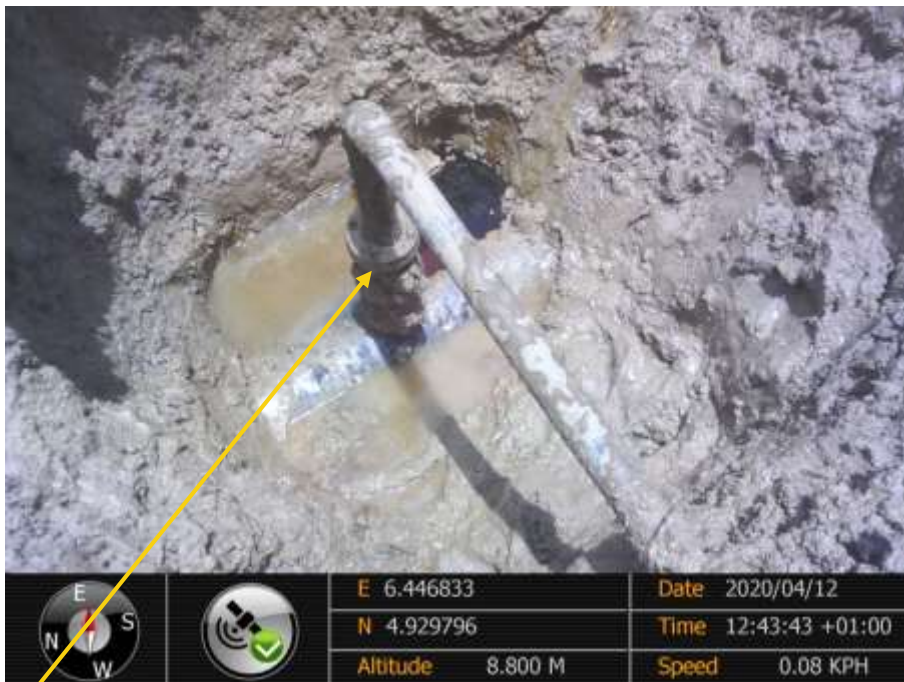
Close-up: 3" ball valve flange installed at 12 o'clock position on 20" Kolocreek – Rumuekpe Pipeline at Odau KM10. Picture was taken during Joint Investigation of 12<sup>th</sup> April 2020.
