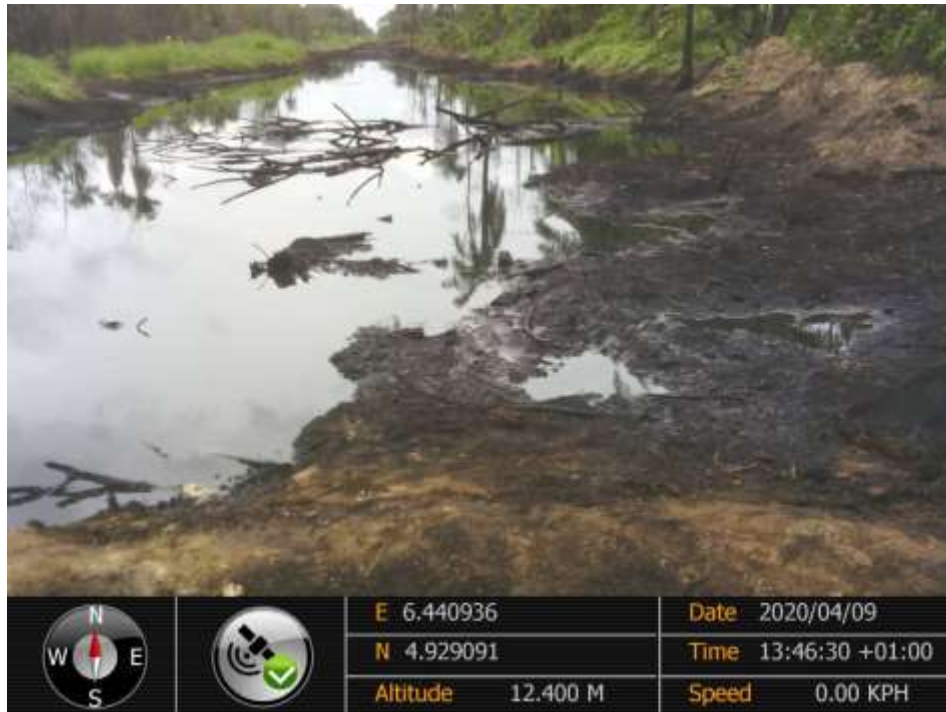
Overview: Part of spill impact on 20” Kolocreek Rumuekpe Pipeline at Odau KP9. Picture was taken during Joint Investigation of 9th April 2020.

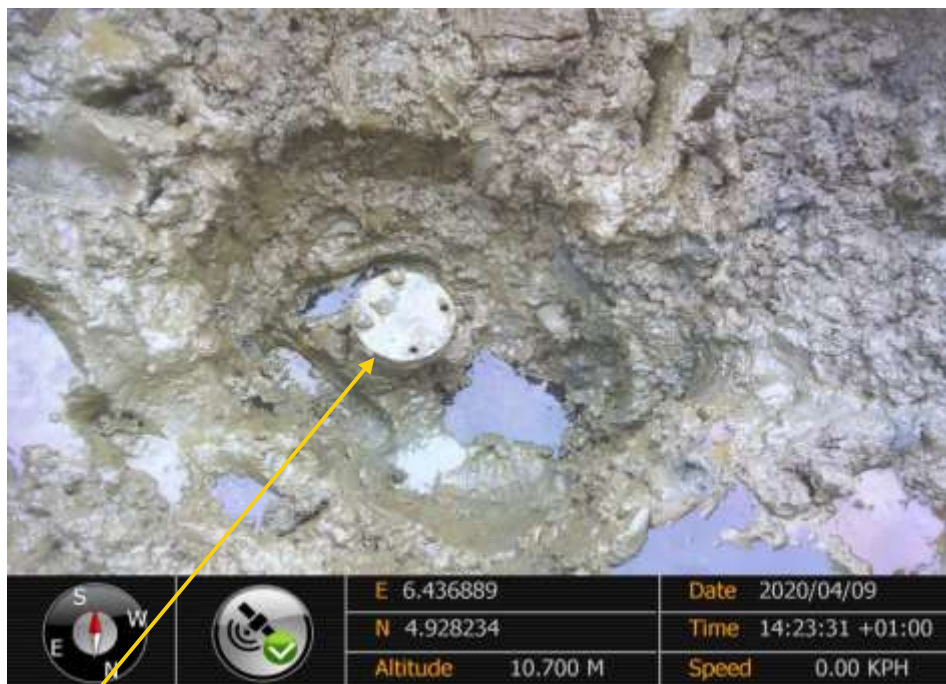
Close-up: Failed 3” theft fittings installed at 12 o’clock position on 20” Kolocreek Rumuekpe Pipeline at Odau KP9. Picture was taken during Joint Investigation of 9th April 2020.
