JOINT INVESTIGATION REPORT

INCIDENT NO: 2626666 JIV report S/N: 0507

1. Incident Number: 2626666 2. Type of incident: OIL SPILL
3. Name of Location: 14th OKORDIA - RUMUKEFE PIPELINE AT OSHIKA
4. Name of nearest community: OSHIKA RIVERS LGA ANKARA WEST
7. Production Facility/Installation: CRUDE OIL PIPELINE
8. Asset Owner/Hub: THE SHELL PETROLEUM DEVELOPMENT COMPANY OF NIGERIA LIMITED (SPDC)/PIPELINE

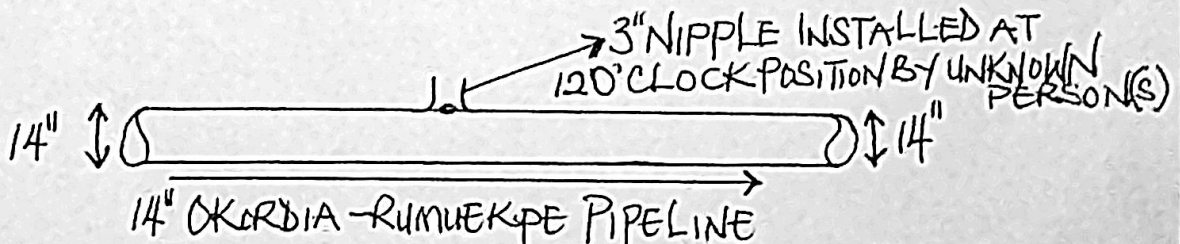
| <input checked="" type="checkbox"/> Crude oil theft (illegal bunkering) point, | <input type="checkbox"/> Saver-pit over flow | <input type="checkbox"/> Third party tampering with Clamp |

E. GRAPHIC DESCRIPTION OF LEAK POINT (while detailed description of the leak point should be contained in the leak report, overview sketch of the site should be added as appendix 1) A SECTION OF 14" OKORDIA-RUMUEKPE PIPELINE AT OSIKA SHOWING 3" NIPPLE INSTALLED AT 12 O'CLOCK POSITION BY UNKNOWN PERSON(S).

CLAMPING ACTIVITY ON-GOING
