# JOINT INVESTIGATION REPORT

INCIDENT NO: 2629757 JIV report S/N: 0510

1. Fountain Incident Number: 2629757 2. Type of incident\* OIL SPILL  
3. Name of Location 6" IMO RIVER WELL 26 FLOW LINE AT IGIRIUKWU  
4. Name of nearest community IGIRIUKWU IN OWAZA 5. State: ABIA 6. LGA UKWA WEST  
7. Production Facility/Installation OIL FLOW LINE  
8. Asset Owner/Hub THE SHELL PETROLEUM DEVELOPMENT COMPANY OF NIGERIA LIMITED (SPDC) / PIPELINE LAND EAST HUB

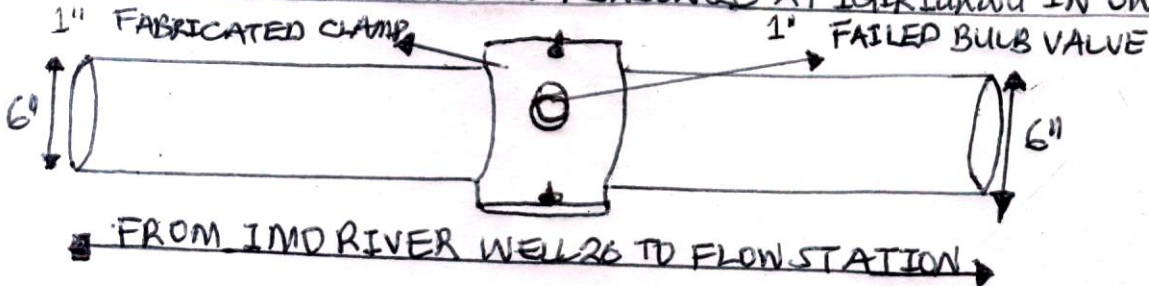
**E. GRAPHIC DESCRIPTION OF LEAK POINT** (while detailed description of the leak point should be contained in the leak report, overview sketch of the site should be added as appendix 1)

A SECTION OF 6" IMOR ~~OR~~ WELLS 26 PIPELINE WORN  
AN ILLEGALLY FABRICATED 1" CLAMP AT 12 O'CLOCK POSITION  
INSTALLED BY UNKNOWN PERSON(S) AT IGERIUKWU IN OWAZA
