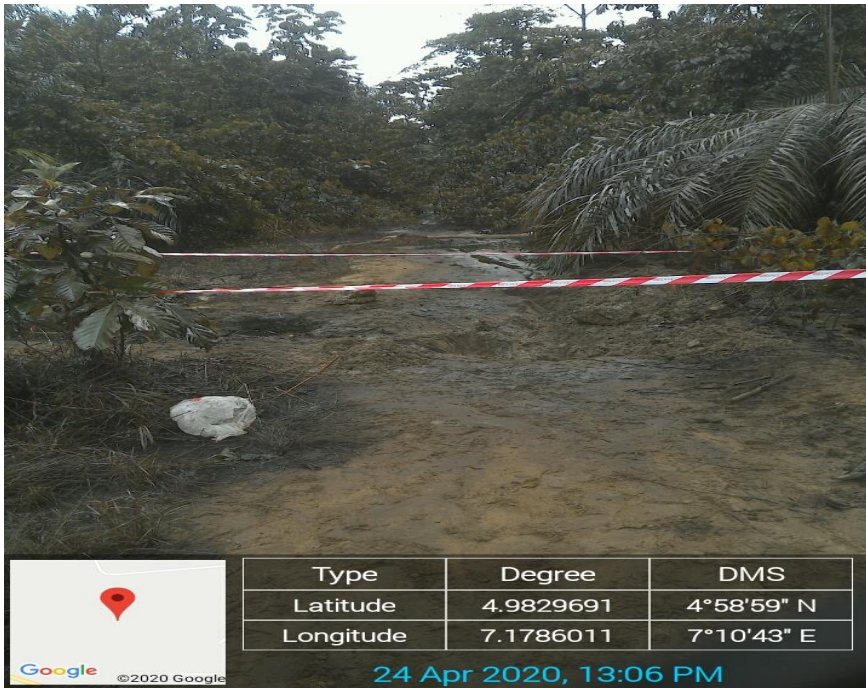
**Overview:** Part of spill impact on 6" Imo River Well 26 Flowline at Igiriukwu. Picture was taken during Joint Investigation of 24<sup>th</sup> April 2020.

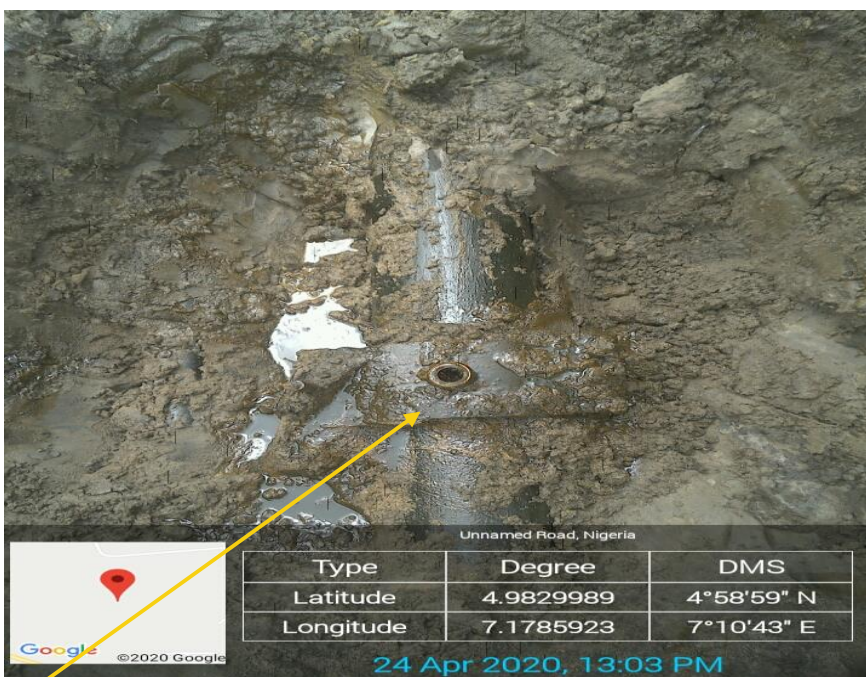
**Close-up:** Illegally fabricated 1" clamp at 12 o'clock position on 6" Imo River Well 26 Flowline at Igiriukwu. Picture was taken during Joint Investigation of 24<sup>th</sup> April 2020.
