JOINT INVESTIGATION REPORT

INCIDENT NO: 2635959 JIV report S/N: 0485

- 1. Fountain Incident Number: 2635959
- 2. Type of incident* DIL SPILL
- 3. Name of Location: 12" TMOR 2 - OGARE PIPELINE
- 4. Name of nearest community UMUDOLOLO 5. State: ABIA 6. LGA UKWA WEST
- 7. Production Facility/Installation OIL PIPELINE
- 8. Asset Owner/Hub THE SHELL PETROLEUM DEVELOPMENT COMPANY OF NIGERIA LIMITED (SPDC) PIPELINE

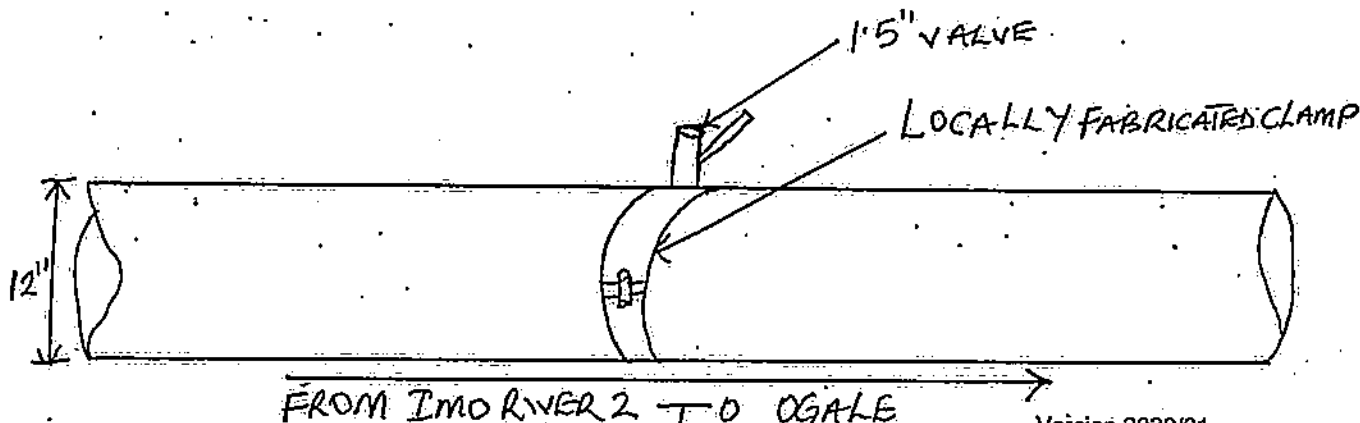
| <input checked="" type="checkbox"/> Crude oil theft (illegal bunkering) point, | <input type="checkbox"/> Saver-pit over flow | <input type="checkbox"/> Third party tampering with Clamp |

E. GRAPHIC DESCRIPTION OF LEAK POINT (while detailed description of the leak point should be contained in the leak report, overview sketch of the site should be added as appendix 1) A SECTION OF 12" IMO RIVER 2-OGALE PIPELINE AT YMUOLOLO SHOWING 1 NOS CRUDE OIL THEFT POINT INSTALLED AT 12 O' CLOCK POSITION. BY UNKNOWN PERSONS

SPILL RECOVERY / REPAIR BY CLAMPING
