JOINT INVESTIGATION REPORT

INCIDENT NO: 2627872 JIV report S/N: 0502

1. Fountain Incident Number: 2627872 2. Type of incident* OIL SPILL
3. Name of Location 8th NKALI - IMO RIVER 2 DELIVERY LINE
4. Name of nearest community ODAGWA 5. State: RIVERS 6. LGA ETCHE
7. Production Facility/Installation OIL DELIVERY LINE
8. Asset Owner/Hub THE SHELL PETROLEUM DEVELOPMENT COMPANY OF NIGERIA LTD (SPDC) / PIPELINE

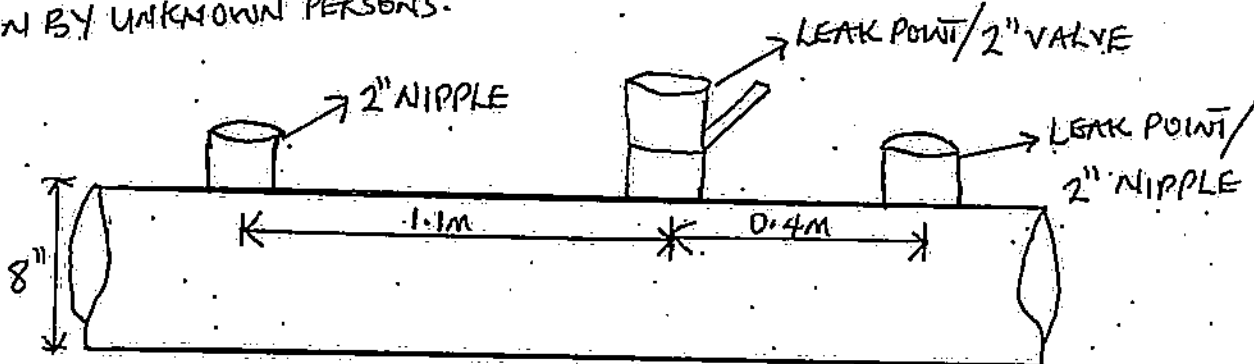
A SECTION OF 8" NKALI - IMO RIVER 2 DELIVERY LINE AT ODAGWA SHOWING 3 NOS CRUDE TIEOFF POINTS INSTALLED 1.1m AND 0.4m APART AT 12 O'CLOCK POSITION BY UNKNOWN PERSONS.

REPAIR BY CLAMPING
