JOINT INVESTIGATION REPORT

INCIDENT NO: 2629272 JIV report S/N: 0509

1. Fountain Incident Number: 2629272 2. Type of incident* OIL SPILL
3. Name of Location 12" IMDB1 - OGALE PIPELINE
ETITIUZO
4. Name of nearest community INUMUOLDLO 5. State: ABIA 6. LGA UKWA WEST
7. Production Facility/Installation OIL PIPELINE
8. Asset Owner/Hub THE SHELL PETROLEUM DEVELOPMENT COMPANY OF NIGERIA LIMITED (SPDC)/ PIPELINE

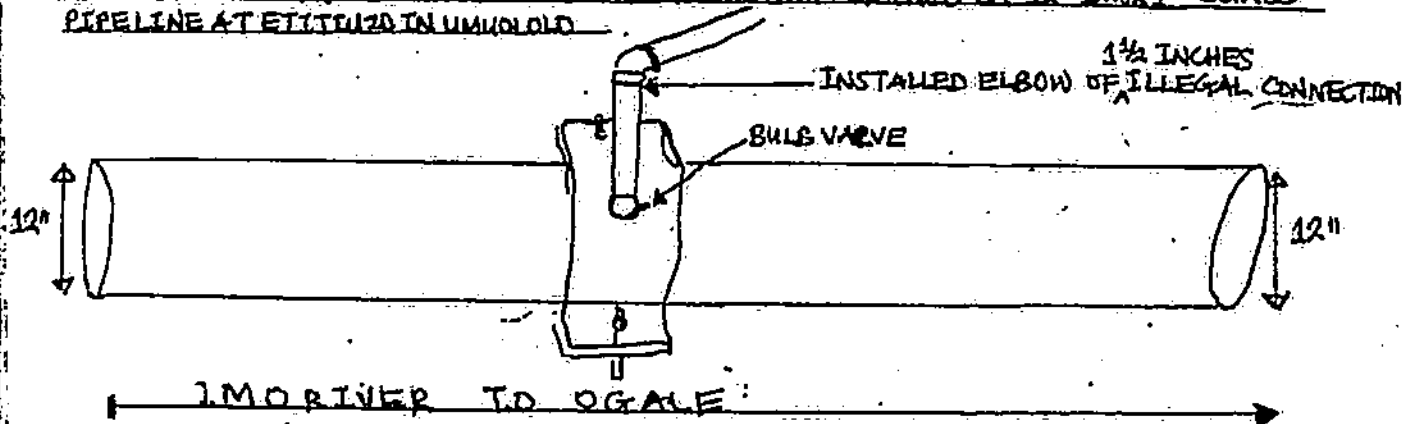
E. GRAPHIC DESCRIPTION OF LEAK POINT (while detailed description of the leak point should be contained in the leak report, overview sketch of the site should be added as appendix 1)

A SECTION OF 1 1/2 INCHES LOCALLY FABRICATED CLAMPED INSTALLATION WITH AN ELBOW WORN AT 12 O'CLOCK POSITION BY UNKNOWN PERSON(S) ON 12" IMOR 1 - OGALE PIPELINE AT ETITUZO IN UMUOLO

CAUSE OF SPILL: THIRD PARTY INTERFERENCE

SPILL RECOVERY / REPAIRS BY CLAMPING
