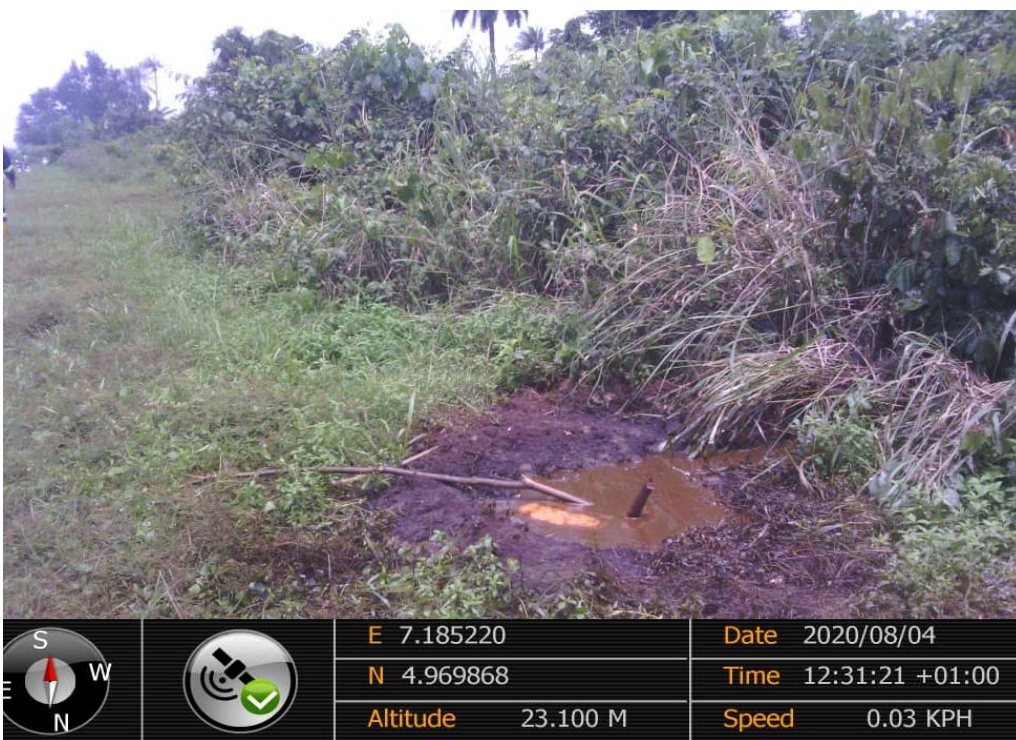
Overview: Part of spill impact on 12" ImoRiver2 - Ogale Pipeline at Umulolo. Picture was taken during Joint Investigation 4th August 2020.

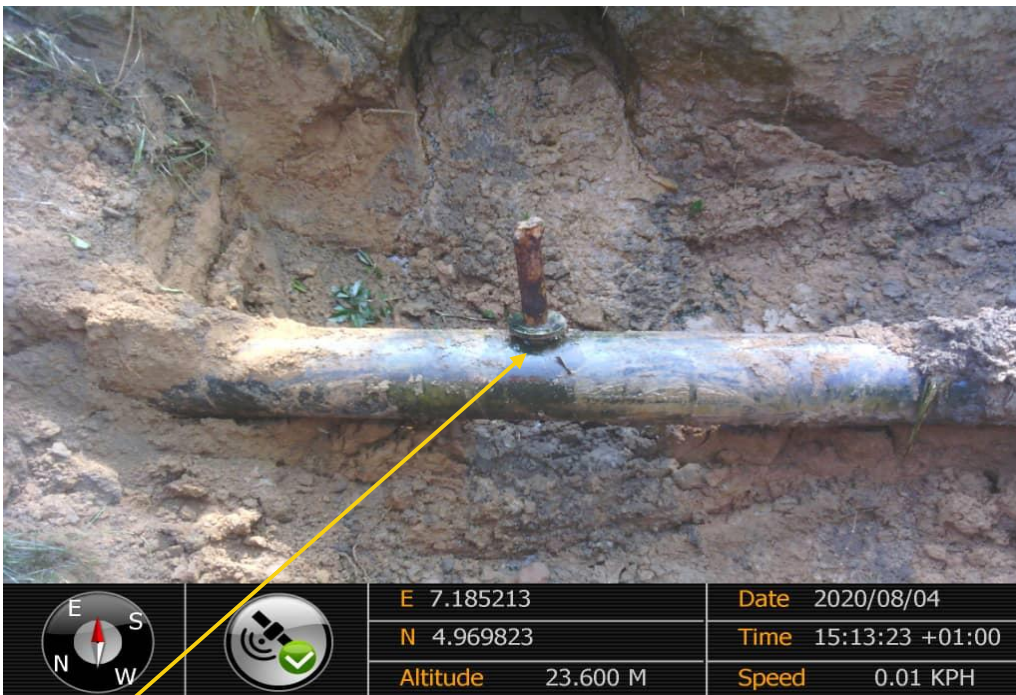
Close-up: 3" Welded Neck Flange installed at 12 o'clock position on 12" ImoRiver2 - Ogale Pipeline at Umulolo. Picture was taken during Joint Investigation 4th August 2020.
