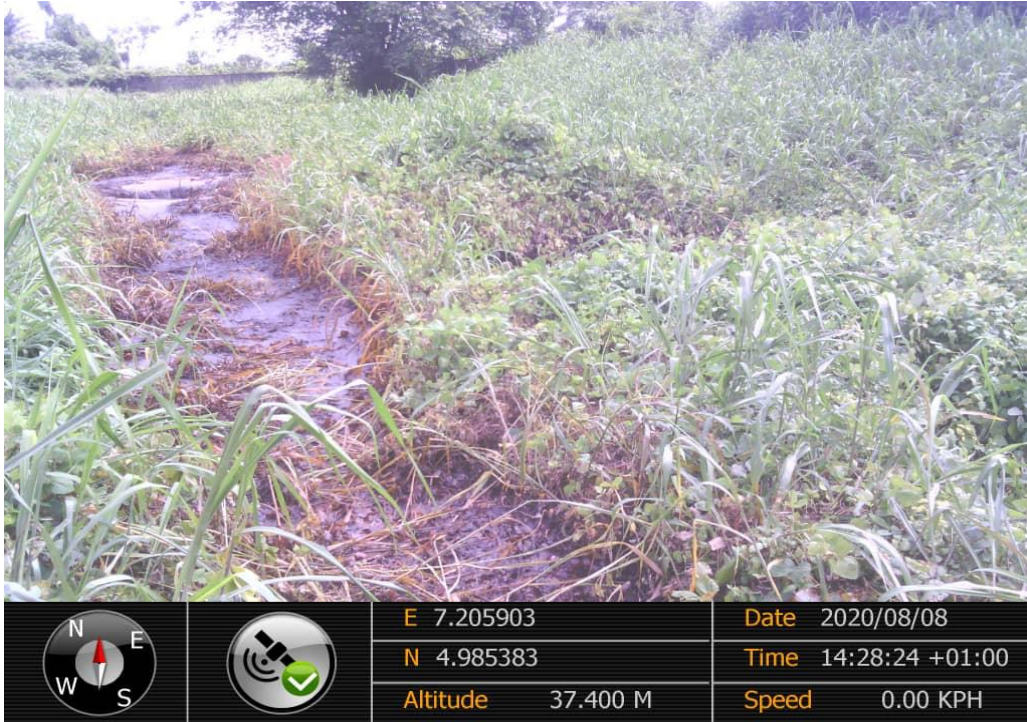
Overview: Part of spill impact on 6" Imo River Well 59T Flowline at Igiriukwu-Owaza. Picture was taken during Joint Investigation of 8th August 2020.

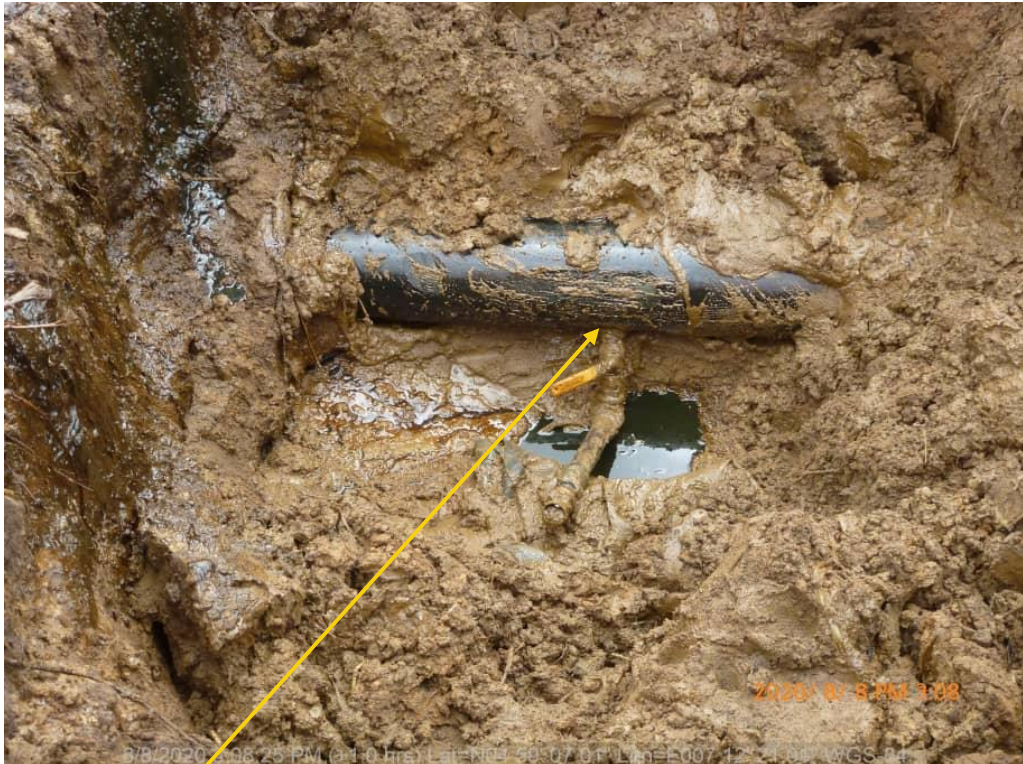
Close-up: Crude oil theft point installed at 7 o'clock position on 6" Imo River Well 59T Flowline at Igiriukwu-Owaza. Picture was taken during Joint Investigation of 8th August 2020.
