JOINT INVESTIGATION REPORT

INCIDENT NO: 2707320 JIV report S/N:

1. Fountain Incident Number: 2707320 2. Type of incident* OIL SPILL
3. Name of Location 14th OKORDIA - RUMUEKPE PIPELINE
4. Name of nearest community ULA-IKATA 5. State: RIVERS 6. LGA AKADA - EAST
7. Production Facility/Installation OIL PIPELINE
8. Asset Owner/Hub THE SHELL PETROLEUM DEVELOPMENT COMPANY
OF NIGERIA LIMITED (SPDC)/PIPELINE

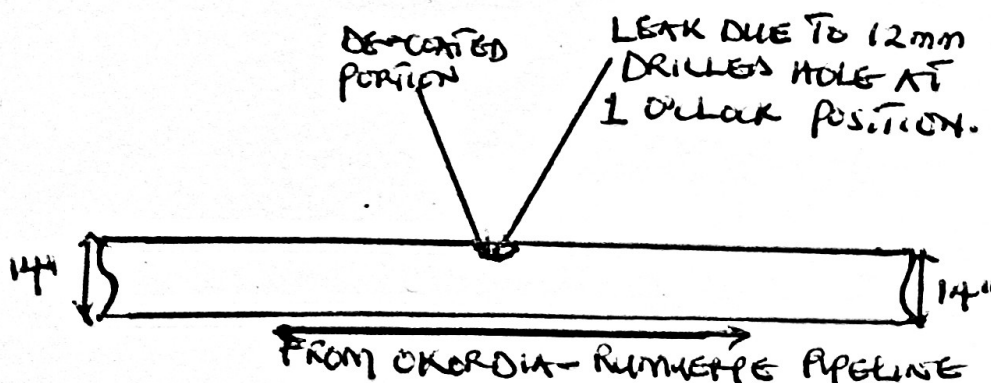
| <input checked="" type="checkbox"/> Smooth round-edge hole | <input type="checkbox"/> Rough-edge hole | <input type="checkbox"/> Hack saw cut |

- ☒ Third party interference (Sabotage ☒; crude theft ☐; Line theft ☐; Accidental 3rd party damage ☐
☐ Operational ☐ Others (including Mystery spills) _____

A SECTION OF 14" OKORDIA-RUMUENGE PIPELINE AT ULA-IMTA SHOWING A 12mm DRILLED HOLE AT 1 O'CLOCK POSITION DONE BY UNKNOWN PERSONS.

REPAIR AND CRUDE OIL RECOVERY ACTIVITIES ONGOING
