JOINT INVESTIGATION REPORT

INCIDENT NO: 2700706 JIV report S/N: 0585

1. Fountain Incident Number: 2700706 2. Type of incident* OIL SPILL
3. Name of Location 14" OKORDIA - KUMBERPE PIPELINE
4. Name of nearest community EDBOHA 5. State: RIVERS 6. LGA ABUJA-EAST
7. Production Facility/Installation OIL PIPELINE
8. Asset Owner/Hub THE SHELL PETROLEUM DEVELOPMENT COMPANY OF NIGERIA LIMITED (SPDC) / PIPELINE

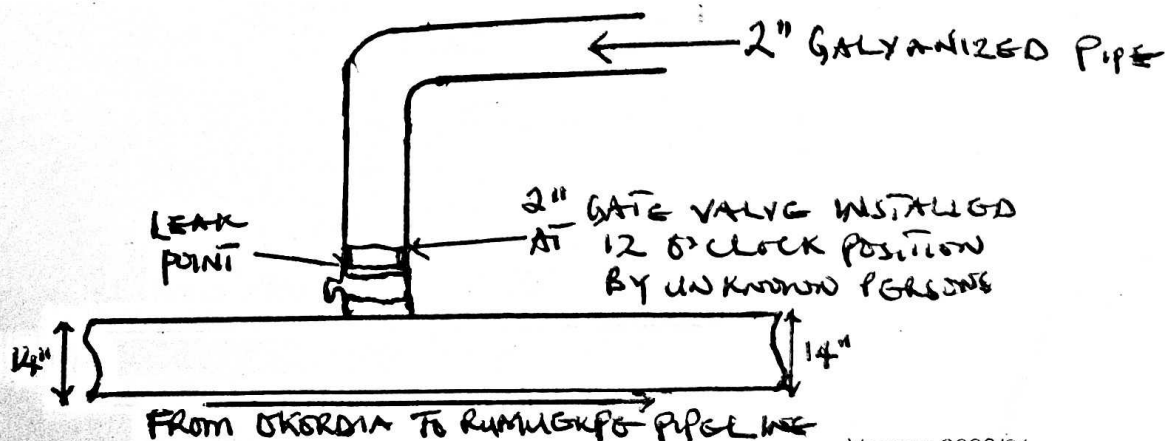
| <input checked="" type="checkbox"/> Crude oil theft (illegal bunkering) point, | <input type="checkbox"/> Saver-pit over flow | <input type="checkbox"/> Third party tampering with Clamp |

- ☒ Third party interference (Sabotage ☐; crude theft ☒; Line theft ☐; Accidental 3rd party damage ☐
☐ Operational ☐ Others (including Mystery spills) _____

E. GRAPHIC DESCRIPTION OF LEAK POINT (while detailed description of the leak point should be contained in the leak report, overview sketch of the site should be added as appendix 1) A SECTION OF 14" OKORDA-RUMUKPO PIPELINE AT EDEOMA SHOWING A 2" GATE VALVE AND A 2" GALVANIZED PIPE INSTALLED AT 12 O'CLOCK POSITION BY UNKNOWN PERSONS.
