JOINT INVESTIGATION REPORT

INCIDENT NO: 2709278 JIV report S/N:

1. Fountain Incident Number: 2709278 2. Type of incident* OIL SPILL
3. Name of Location: 12" IMO RIVER 1 - OGALE PIPELINE
4. Name of nearest community: OKOHA 5. State: ABIA 6. LGA UKWA WEST
7. Production Facility/Installation CRUDE OIL PIPELINE
8. Asset Owner/Hub THE SHELL PETROLEUM DEVELOPMENT COMPANY
OF NIGERIA LIMITED / PIPELINE

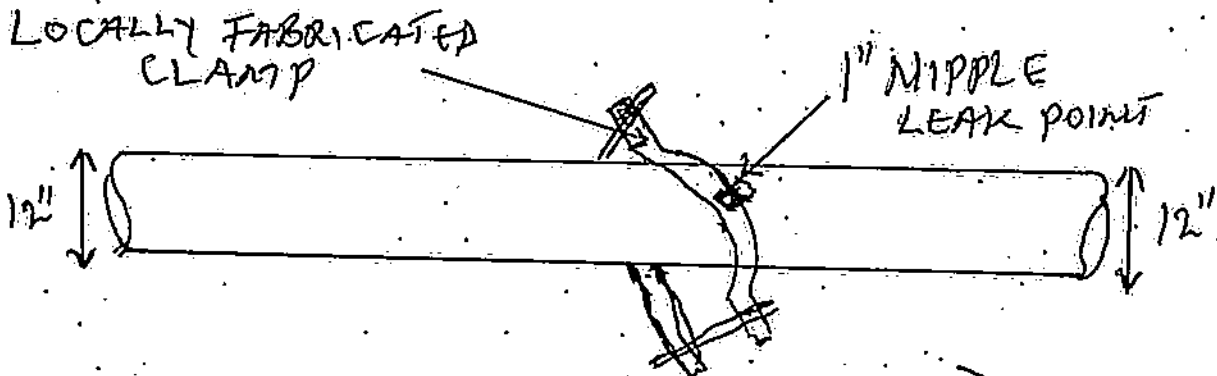
| <input checked="" type="checkbox"/> Crude oil theft (illegal bunkering) point, | <input type="checkbox"/> Saver-pit over flow | <input type="checkbox"/> Third party tampering with Clamp |

- Third party interference (Sabotage ; crude theft ; Line theft ; Accidental 3rd party damage
 Operational Others (including Mystery spills) _____

SECTION OF 12" MOTORER 1 - OGALE PIPELINE AT OKDAMA SHOWING CRUDE OIL TIGHT POINT INSTALLED AT 12 O'CLOCK POSITION BY UNKNOWN PERSON(S)

REPAIR WORK BY CLAMPING COMPLETED, CRUDE OIL RECOVERY ACTIVITIES ONGOING.
