JOINT INVESTIGATION REPORT

INCIDENT NO: 2713439 JIV report S/N: 0689

1. Fountain Incident Number: 2713439 2. Type of incident* OIL SPILL
3. Name of Location 4" IMO RIVER I WELL 36S FLOWLINE
4. Name of nearest community ISIETITIOHA 5. State: ABIA 6. LGA UKWA WEST
7. Production Facility/Installation FLOWLINE
8. Asset Owner/Hub THE SHELL PETROLEUM DEVELOPMENT COMPANY OF NIGERIA LTD (SPDC) /LAND EAST HUB

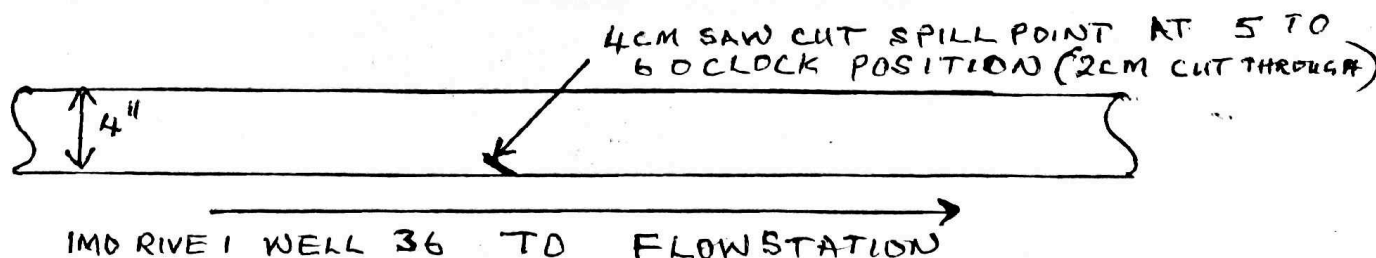
E. GRAPHIC DESCRIPTION OF LEAK POINT (while detailed description of the leak point should be contained in the leak report, overview sketch of the site should be added as appendix 1). A SECTION 4" IMO RIVER I WELL 36 S FLOWLINE AT 131ETITIDHA SHOWING 4CM HACK SAW CUT AT 5 TO 6 O'CLOCK POSITION DONE BY UNKNOWN PERSONS.
