# JOINT INVESTIGATION REPORT

INCIDENT NO: 2714059 JIV report S/N: 0685

1. Fountain Incident Number: 2714059 2. Type of incident\* OIL SPILL  
3. Name of Location 20" KOLO CREEK - RUMUEKPE TRUNKLINE PIPELINE  
4. Name of nearest community IHUOWO 5. State: RIVERS 6. LGA AHOADA-EAST  
7. Production Facility/Installation OIL PIPELINE  
8. Asset Owner/Hub THE SHELL PETROLEUM DEVELOPMENT COMPANY OF NIGERIA LIMITED (SPDC) / PIPELINE

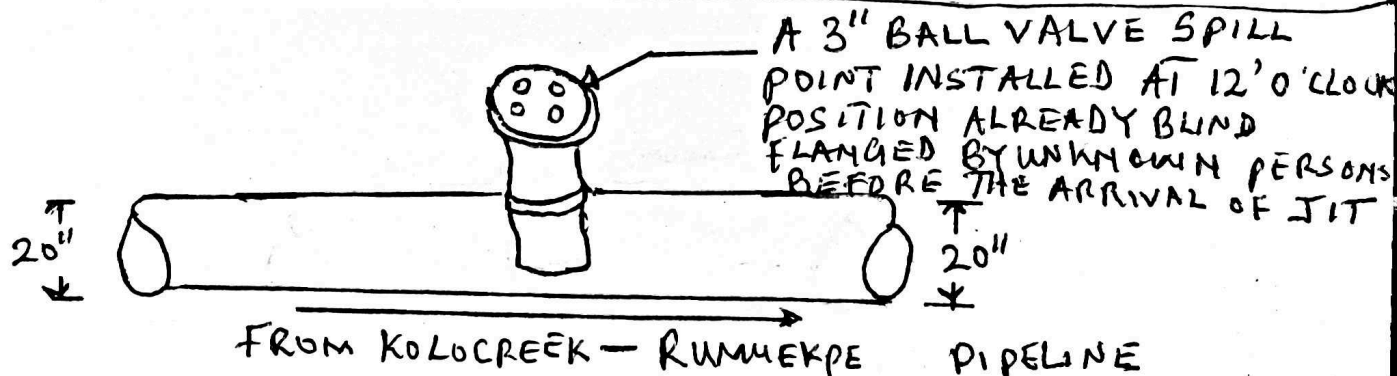
E. GRAPHIC DESCRIPTION OF LEAK POINT (while detailed description of the leak point should be contained in the leak report, overview sketch of the site should be added as appendix 1).

A SECTION OF 20" KOLO CREEK - RUMMEKPE TRUNK LINE (PIPELINE) AT IHUOMO SHOWING A 3" BALL VALVE (CRUDE OIL THEFT POINT) INSTALLED AT 12 O'CLOCK POSITION BY UNKNOWN PERSONS.
