JOINT INVESTIGATION REPORT

INCIDENT NO: 2718876 JIV report S/N: 0690

1. Fountain Incident Number: 2718876 2. Type of incident* OIL SPILL
3. Name of Location 28" BOMU - BONNY PIPELINE
4. Name of nearest community OWOKIRI 5. State: RIVERS 6. LGA ANDONI
7. Production Facility/Installation OIL PIPELINE
8. Asset Owner/Hub THE SHELL PETROLEUM DEVELOPMENT COMPANY OF NIGERIA LTD (SPDC) / PIPELINE

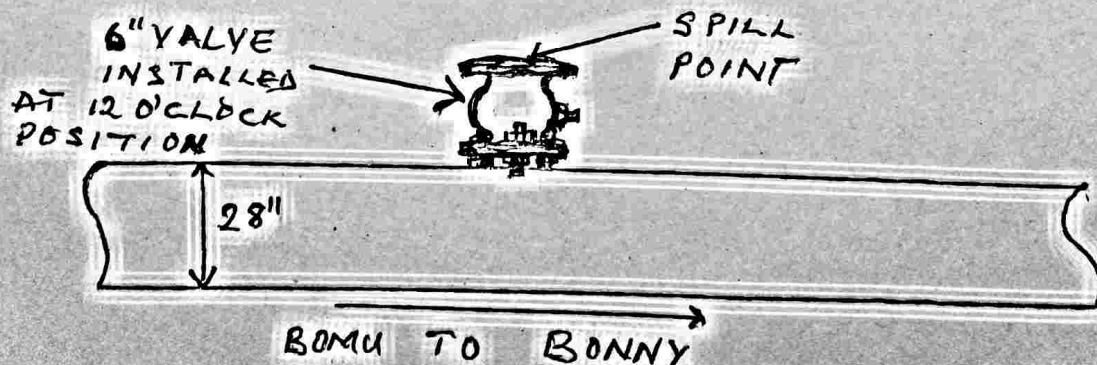
| <input checked="" type="checkbox"/> Crude oil theft (illegal bunkering) point, | <input type="checkbox"/> Saver-pit over flow | <input type="checkbox"/> Third party tampering with Clamp |

- ☒ Third party interference (Sabotage ☐; crude theft ☒; Line theft ☐; Accidental 3rd party damage ☐
☐ Operational ☐ Others (including Mystery spills) _____

BOMU - BONNY PIPELINE AT OWOKIRI SHOWING 6" CRUDE OIL THEFT VALVE, INSTALLED AT 12 O'CLOCK POSITION BY UNKNOWN PERSON(S)

BLIND FLANGING
