JOINT INVESTIGATION REPORT

INCIDENT NO: 2722143 JIV report S/N: 0682

1. Fountain Incident Number: 2722143 2. Type of incident* OIL SPILL
3. Name of Location 12th IMO RIVER 1 - OGALE PIPELINE
4. Name of nearest community: OGALE 5. State: RIVERS 6. LGA ELEME
7. Production Facility/Installation CRUDE OIL PIPELINE
8. Asset Owner/Hub THE SHELL PETROLEUM DEVELOPMENT COMPANY
OF NIGERIA LIMITED / PIPELINE

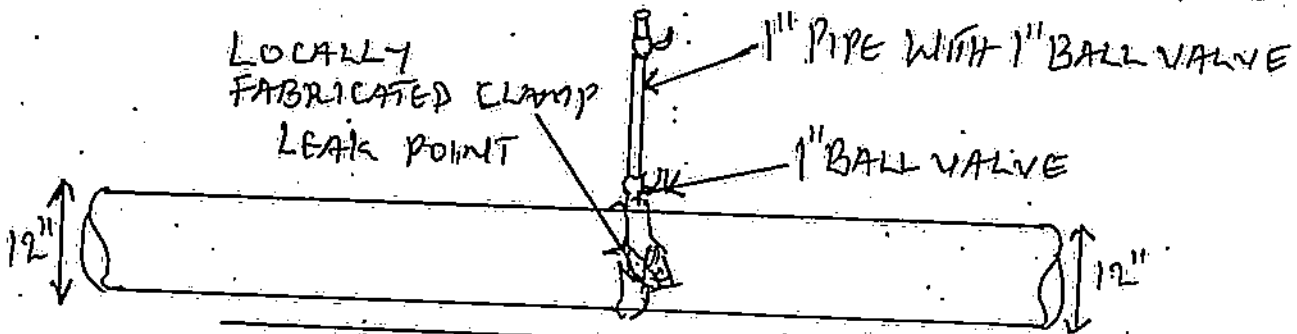
SECTION OF 12" IMORIVER 1 - OGALE PIPELINE AT OGALE SHOWING CRUDE OIL THEFT POINT INSTALLED AT 12 O'CLOCK POSITION BY UNKNOWN PERSONS.

FROM IMORIVER 1 TO OGALE

REPAIR WAS DONE BY CLAMPING.
