INCIDENT NO: 2799487 JIV report S/N:

A. GENERAL INFORMATION:	
1. Fountain Incident Number: 279948	7 2. Type of incident* OTL SPILL RUMUEKPE PIPELINE 5. State: RIVERS 6. LGA EMEHUA
3. Name of Location 14" OKORDIA -	RUMUEKPE PIPELINE

4. Name of nearest community NAMUEK E	5. State: RIVERS 6. LGA EMCHUA
7 December 1 - 11: 17 . 11 . 17 . 19 . 19 . 19 . 19 . 19 .	21:12
8. Asset Owner/Hub THE SHELL PE	TROLEUM DEVELOPMENT COMPANY
OF NIGERIA LIM B. INCIDENT INFORMATION:	TROLEUM DEVELOPMENT CEMPANY ITED (SPOC)/PIPELIME

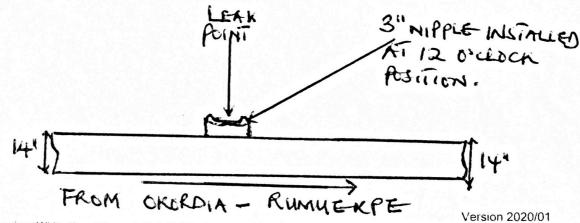
20. Others (Specify) e.g. Animal Traps S/N Others Description Quantity/Size Comments
NONE WITHIN AREA OF IMPACT
. GRAPHIC DESCRIPTION OF LEAK POINT (while detailed description of the leak point should be contained
HAPPIC DESCRIPTION OF LEAK POINT (while detailed description of the leak point should be contained to the leak report, overview sketch of the site should be added as appendix 1) A SECTION 14" EXCLOSUME KPE PELINE AT RUMUEKPE SHOWING A 3" NIPPLE
WTALLED AT 12 OPLLOCK POSITION BY UNKNOWN FERSONS
POINT 3" NIPPLE INSTALLED
AT 12 o'clock
