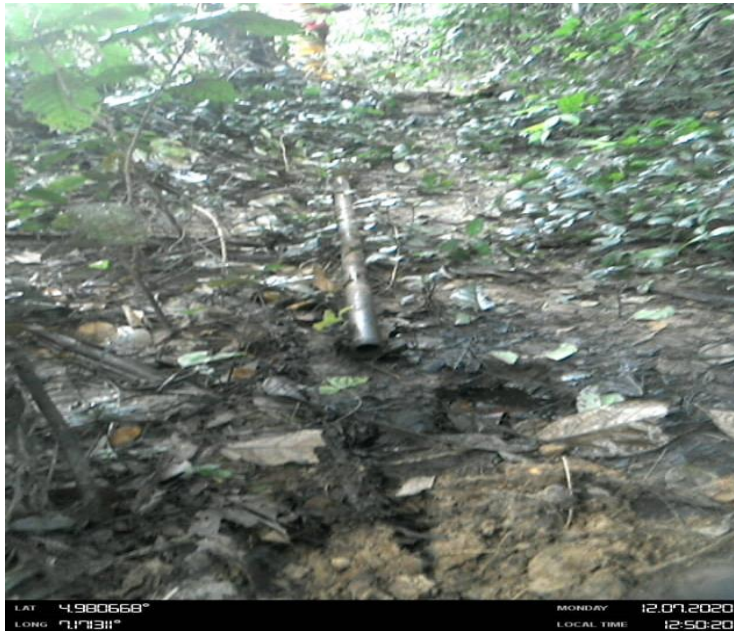
Overview: Part of spill impact on 4" ImoRiverWell 60T Flowline at Odagwa. Picture was taken during Joint Investigation on 7th December 2020.

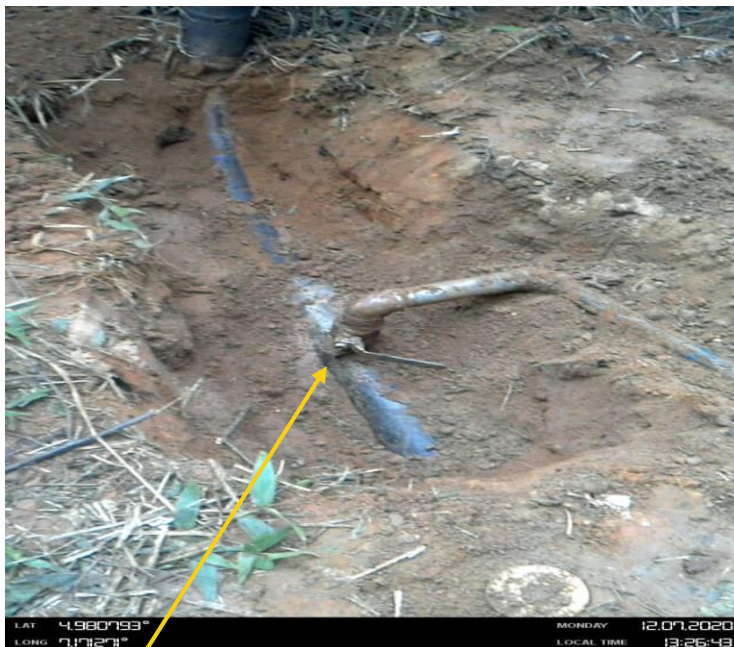
Close-up: Crude oil theft point installed at 12 o'clock position on 4" ImoRiverWell 60T Flowline at Odagwa. Picture was taken during Joint Investigation on 7th December 2020.
