JOINT INVESTIGATION REPORT

INCIDENT NO: 2814845 JIV report S/N:

1. Fountain Incident Number: 2814845 2. Type of incident* OIL SPILL
3. Name of Location 14th OKORDIA - RUMUOKPE PIPELINE
4. Name of nearest community FODOHA 5. State: RIVERS 6. LGA AHEADADA - EAST
7. Production Facility/Installation OIL PIPELINE
8. Asset Owner/Hub THE SHELL PETROLEUM DEVELOPMENT COMPANY OF NIGERIA LIMITED (SPDC) / PIPELINE

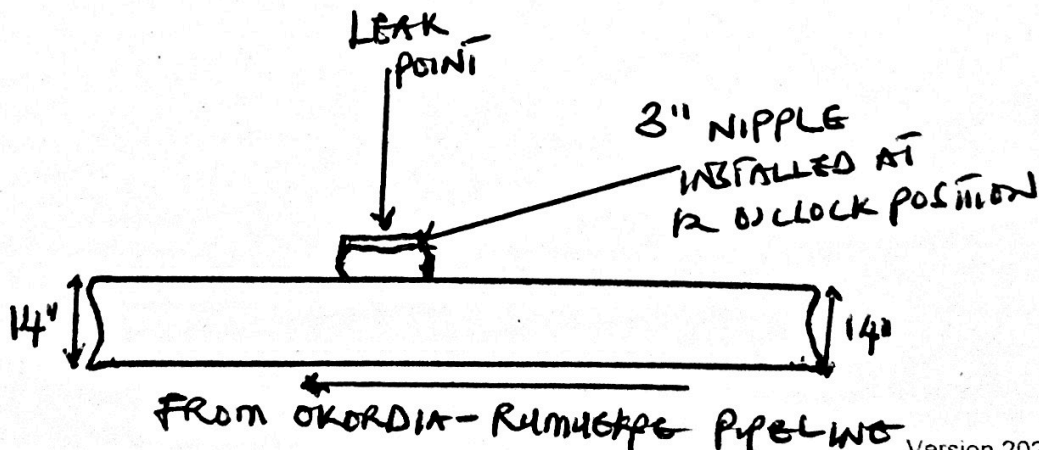
| <input checked="" type="checkbox"/> Crude oil theft (illegal bunkering) point, | <input type="checkbox"/> Saver-pit over flow | <input type="checkbox"/> Third party tampering with Clamp |

A SECTION OF 14" OKORDIA-RUMUKPE PIPELINE AT EDECHA SHOWING A 3" NIPPLE INSTALLED AT 12 O'CLOCK POSITION BY UNKNOWN PERSONS.

REPAIR ACTIVITIES ONGOING
