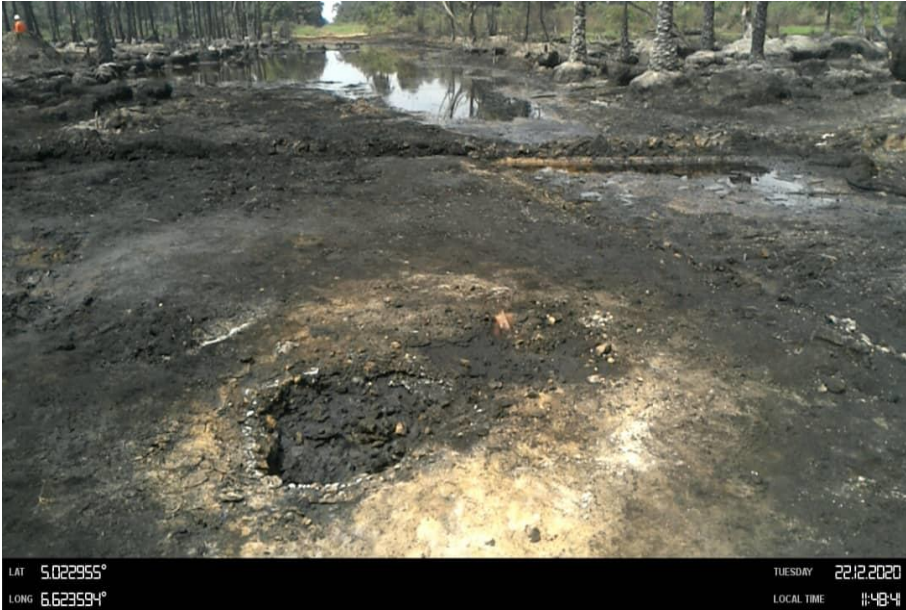
**Overview:** Part of spill impact on 14" Okordia Rumuekpe Pipeine at Edeoha.  
Picture was taken during Joint Investigation on 22nd Dec 2020.

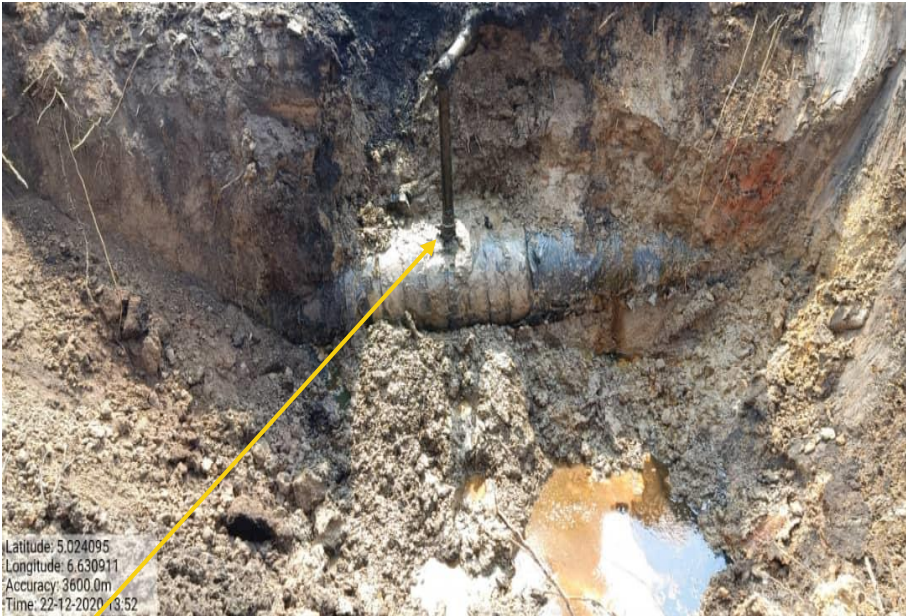
**Close-up:** 2" valve installed at 12 o'clock position connected to a 2" galvanized pipe on 14" Okordia Rumuekpe Pipeine at Edeoha. Picture was taken during Joint Investigation on 22nd Dec 2020.
