JOINT INVESTIGATION REPORT

INCIDENT NO: 2812731 JIV report S/N: 0619

1. Fountain Incident Number: 2812731 2. Type of incident* OIL SPILL
3. Name of Location 14th OKORDIA - RUMUEKPE PIPELINE
4. Name of nearest community EDEOHA 5. State: RIVERS 6. LGA AHOADA-EAST
7. Production Facility/Installation OIL PIPELINE
8. Asset Owner/Hub THE SHELL PETROLEUM DEVELOPMENT COMPANY OF NIGERIA LIMITED (SPDC)/PIPELINE

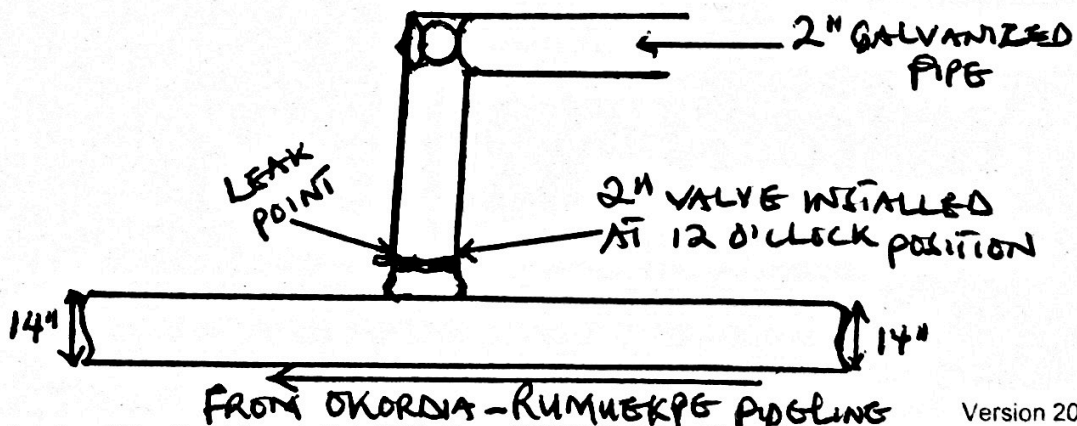
Additional observations around the spill point: BURNT IMPACTED AREA WAS OBSERVED AROUND THE SPILL POINT BY THE JOINT INVESTIGATION TEAM.

E. GRAPHIC DESCRIPTION OF LEAK POINT (while detailed description of the leak point should be contained in the leak report, overview sketch of the site should be added as appendix 1) A SECTION OF 14" OKORDIA - RUMUEKPE PIPELINE AT EDOHA SHOWING A 2" VALVE INSTALLED AT 12 O'CLOCK POSITION CONNECTED TO A 2" GALVANIZED PIPE BY UNKNOWN PERSONS.

CRUDE OIL RECOVERY AND REPAIR ACTIVITIES
