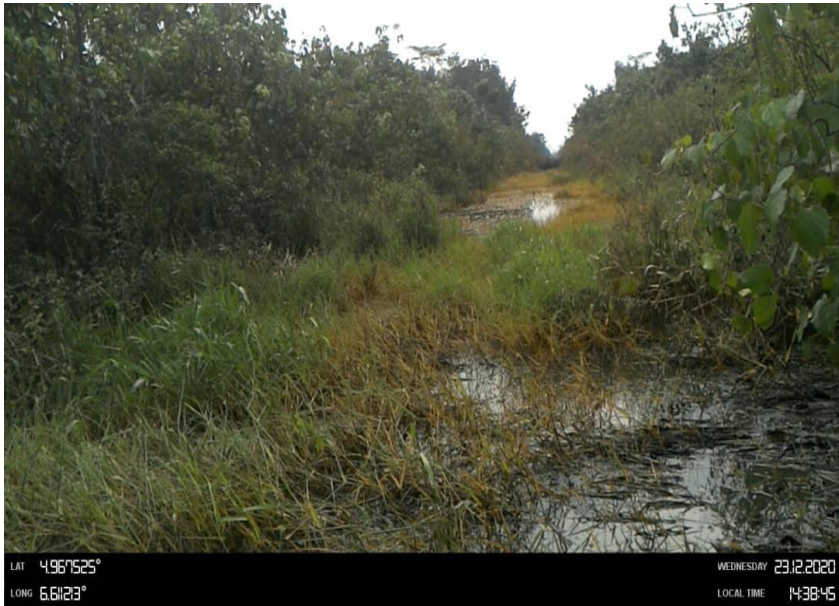
Overview: Part of spill impact on 20'' Kolocreek Rumuekpe Pipeine at Owerewere. Picture was taken during Joint Investigation on 23rd Dec 2020.

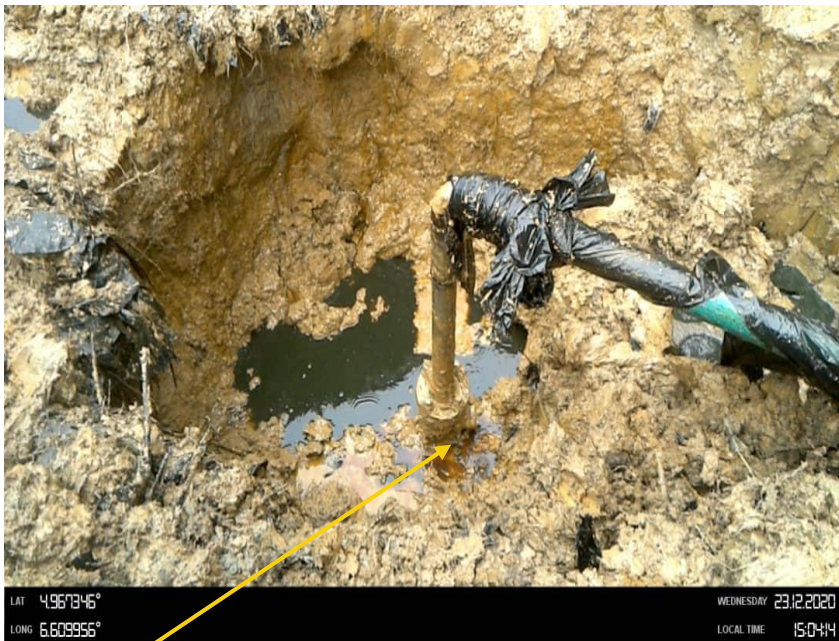
Close-up: 2'' valve installed at 12 o'clock position connected to a 2'' galvanized pipe on 20'' Kolocreek Rumuekpe Pipeine at Owerewere. Picture was taken during Joint Investigation on 23rd Dec 2020.
