# JOINT INVESTIGATION REPORT

INCIDENT NO: 2812710 JIV report S/N: 0628

1. Fountain Incident Number: 2812710 2. Type of incident\* OIL SPILL  
3. Name of Location 36" NKPOKU - OGALE PIPELINE  
4. Name of nearest community AGBONCHIA 5. State: RIVERS 6. LGA ELEME  
7. Production Facility/Installation PIPELINE  
8. Asset Owner/Hub THE SHELL PETROLEUM DEVELOPMENT COMPANY OF NIGERIA LIMITED (SPDC)/PIPELINE

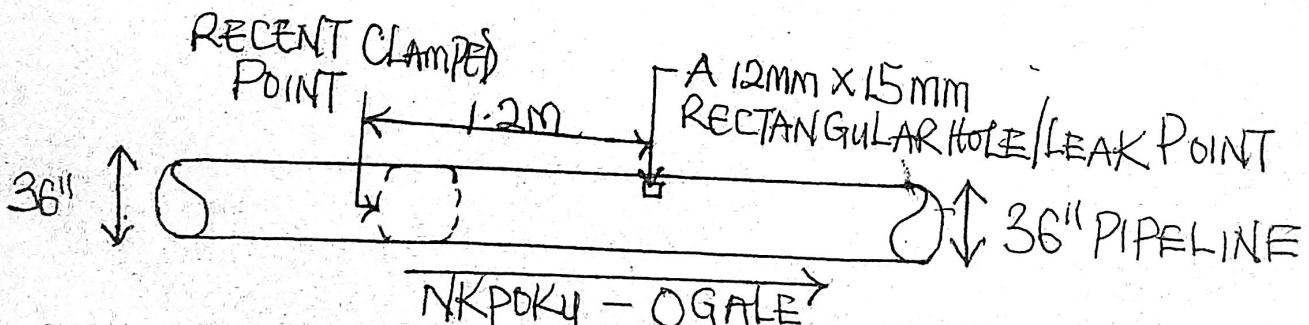
**E. GRAPHIC DESCRIPTION OF LEAK POINT** (while detailed description of the leak point should be contained in the leak report, overview sketch of the site should be added as appendix 1)

A RECENT CLAMPED POINT OF 1.2M APART

| <input checked="" type="checkbox"/> Others (specify) <u>A RECTANGULAR HOLE</u> | | |

A SECTION OF 36" NKPOKU - OGALE PIPELINE AT ABONCHIA SHOWING A RECTANGULAR HOLE OF 12mm x 15mm CREATED AT 10 O'CLOCK POSITION BY UNKNOWN PERSON(S).

REPAIR BY CLAMPING
