INCIDENT NO: 2799385 JIV report S/N:

A. GENERAL INFORMATION:
1. Fountain Incident Number: 2799385 2. Type of incident* DIL SPILL
3. Name of Location 12" FORCADOS LOW PRESSURE DELIVERY LINE.
4. Name of nearest community OGHULHA 5. State: DELTA 6. LGA BURUTU

7. Production Facility/Installation DELIVERY LINE
8. Asset Owner/Hub THE SHELL PETROLEUM DEVELOPMENT COMPANY NIGHT INFORMATION: 8. Asset Owner/Hub THE SHELL PETROLEUM DEVELOPMENT COMPANY B. INCIDENT INFORMATION:

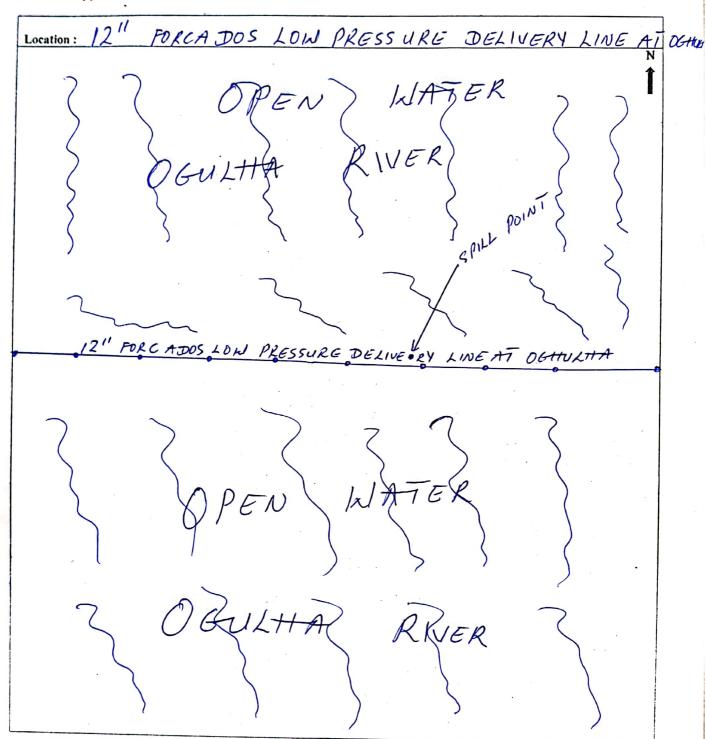
f. Appendix 1: Overview sketch of the site

E. GRAPHIC DESCRIPTION OF LEAK POINT (while detailed description of the leak point should be contained in the leak report, overview sketch of the site should be added as appendix 1)
A SECTION OF 12" FORCADOS LOW PRESSURE DELIVER) LINE AT OGHULHA SHOWING ACOROSSION AT 3 O'CLOCK
POSITION. EXTERNAL CORUSION SPILL POINT
FROM FORCA DOS TO ESTUARY FLOW STATION
FROM FORCADOS TO ESTUARY FLOW STATION
