JOINT INVESTIGATION REPORT

INCIDENT NO: 2577673 JIV report S/N: 1030235

1. Fountain Incident Number: 2577673 2. Type of incident* OIL SPILL
3. Name of Location: 12" MID RIVERA - OGALE PIPELINE
4. Name of nearest community: UZUAKU 5. State: ABIA 6. LGA: UKWA WEST
7. Type of Production facility/Installation: OIL PIPELINE
8. Asset owner/District: THE SHELL PETROLEUM DEVELOPMENT COMPANY
OF NIGERIA LIMITED / PIPELINE

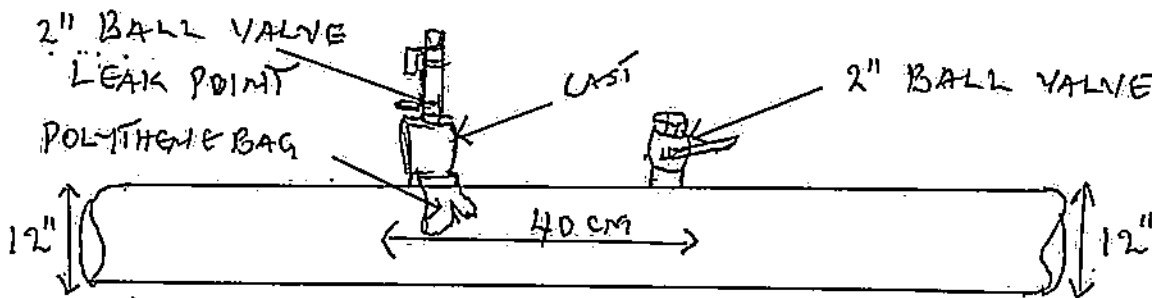
| <input checked="" type="checkbox"/> Failed Weld-on illegal hot tap valve | <input type="checkbox"/> Failed Clamp, | <input type="checkbox"/> Missing Pipeline/Flowline |
| <input checked="" type="checkbox"/> Crude oil theft (illegal bunkering) point, | <input type="checkbox"/> Saver-pit over flow | <input type="checkbox"/> Third party tampering with Clamp |

SECTION OF 12" MORIVER 1 - OGAL PIPELINE AT UZUAKI SHOWING TWO NOS OF CRUDE OIL THEFT POINTS AT 12 O'CLOCK POSITION.
