JOINT INVESTIGATION REPORT

INCIDENT NO: 2582098 JIV report S/N: 0562

1. Fountain Incident Number: 2582098 2. Type of incident* CRUDE OIL SPILL
3. Name of Location 24" TRANS NIGER PIPELINE AT BIARA
4. Name of nearest community BIARA 5. State: RIVERS 6. LGA GOKANA
7. Production Facility/Installation OIL PIPELINE
8. Asset Owner/Hub THE STEEL PETROLEUM DEVELOPMENT COMPANY OF NIGERIA LIMITED (SPDC) / PIPELINE

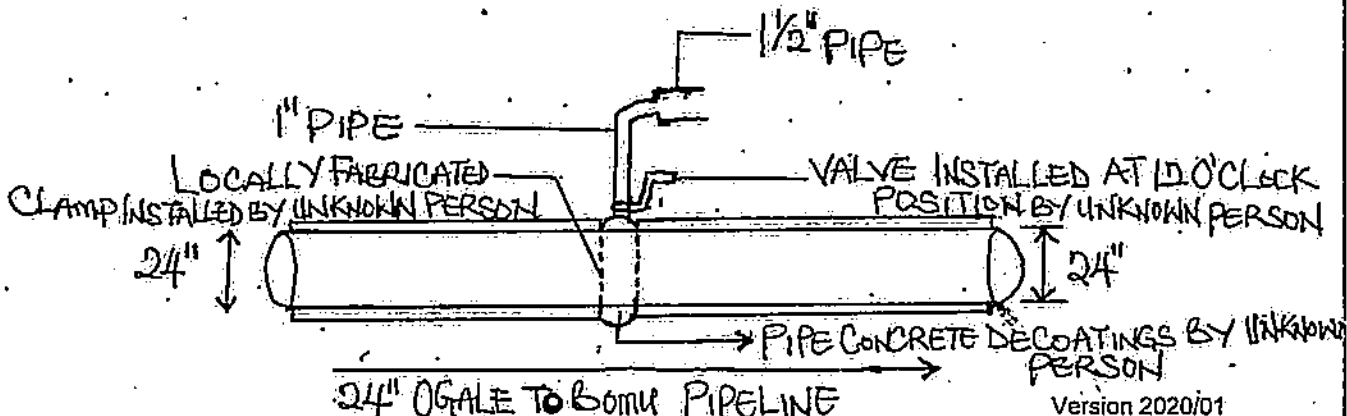
| <input checked="" type="checkbox"/> Crude oil theft (illegal bunkering) point, | <input type="checkbox"/> Saver-pit over flow | <input type="checkbox"/> Third party tampering with Clamp |

E. GRAPHIC DESCRIPTION OF LEAK POINT (while detailed description of the leak point should be contained in the leak report, overview sketch of the site should be added as appendix 1) A SECTION OF 24" OGALE - BOMU PIPELINE AT BIARA SHOWING ONE INCH (1") VALVE INSTALLED AT 12 O'CLOCK POSITION BY UNKNOWN PERSON(S).

REPAIR WORK BY CLAMPING/OIL RECOVERY ON-GOING
