INCIDENT NO: 2544361 JIV report S/N:1030197

A. GENERAL INFORMATION:		to .	
1. Fountain Incident Number: 254436	2.Type of incide	ent* OIL SPILL	
3. Name of Location 12" MORIVE	RI - OGA	LE PIPELINE	
4. Name of nearest community UZUAKU	5. State: <u>ABIA</u> 6	.LGA UKWA-MEST	Ţ

7. Type of Production facility/Installation 🔘 11	PIPELINE		
8. Asset owner/District THE SHELL P	ETROLEUM I	DENELOPMENT CO	MPANY
8. Asset owner/District THE SHELL P. B. INCIDENT INFORMATION:	+ LIMITED /	PIPELINE

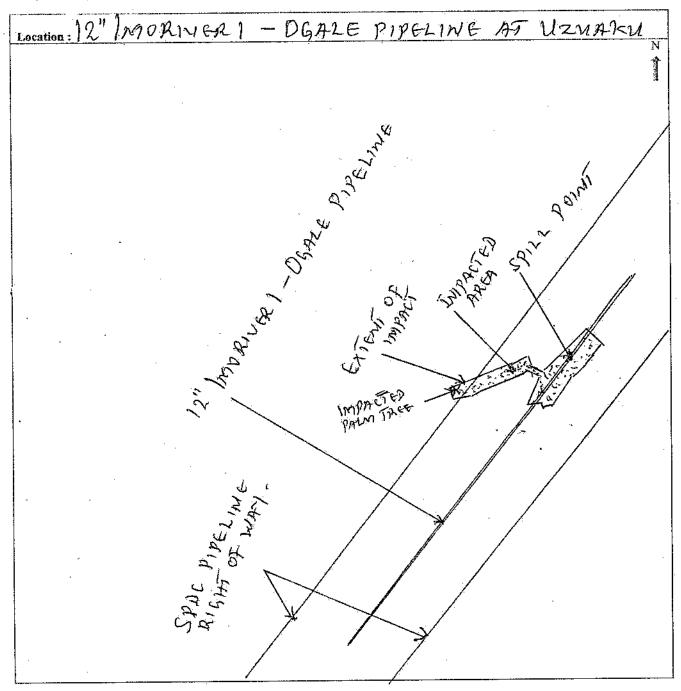
f. Appendix 1: Overview sketch of the site

E. GR	APHIC DESCR	RIPTION	OF LEAK PO	INT (while det	ail repo	rt of the l	eak point	should l	be contained in the
	port, overview s								
NDE O	il THEFT	POIN	175 INSTA	HED AT	120	O'CLC	cic Po	25171	ont.
المنطق بالمار		BALL	VALVE POINT				3" î	34L2	NAZVE
UCRETE CAST~	_	- WT/F	1 Poingi			PR [
₽ ⁄		O.			· · · · · · · · · · · · · · · · · · ·		-		: A
2"				40 CM		→		,) 1211
1/\₩		···········	-				·····		/ √
	FROM IN		VERT T	O DGA	 >
