JOINT INVESTIGATION REPORT

INCIDENT NO: 2542268 JIV report S/N: 1030213

1. Fountain Incident Number: 2542268 2. Type of incident* OIL SPILL
3. Name of Location 20" TRANS - ESCRAVOS PIPELINE AT UGBDEGUN GUN
4. Name of nearest community UGBDEGUN GUN State: DELTA 6. LGA WARRI SOUTH WEST
7. Type of Production facility/Installation PIPELINE
8. Asset owner/District THE SHELL PETROLEUM DEVELOPMENT COMPANY NIGERIA LIMITED / PIPELINE

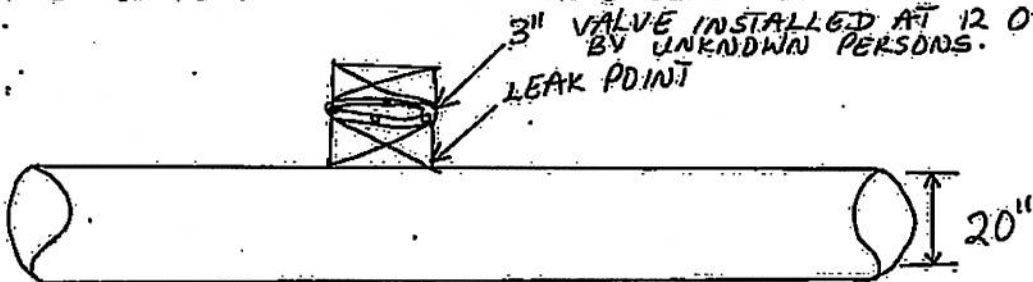
| <input checked="" type="checkbox"/> Failed Weld-on illegal hot tap valve | <input type="checkbox"/> Failed Clamp, | <input type="checkbox"/> Missing Pipeline/Flowline |
| <input checked="" type="checkbox"/> Crude oil theft (illegal bunkering) point, | <input type="checkbox"/> Saver-pit over flow | <input type="checkbox"/> Third party tampering with Clamp |

A SECTION OF 20" TRANS-ESCRAVOS PIPELINE AT UGBOEGUNGUN SHOWING WELD-ON 3" VALVE INSTALLED AT 12 O'CLOCK POSITION BY UNKNOWN PERSONS.
