JOINT INVESTIGATION REPORT

INCIDENT NO: 2548125 JIV report S/N: 1030200

1. Fountain Incident Number: 2548125 2. Type of incident* OIL SPILL
3. Name of Location 12" IMO RIVER - EBURU PIPELINE
ISI ETITI OHA
4. Name of nearest community (OWAZA) 5. State: ABIA 6. LGA UKWA-WEST
7. Type of Production facility/Installation OIL PIPELINE
8. Asset owner/District THE SHELL PETROLEUM DEVELOPMENT COMPANY OF NIGERIA LTD (SPDC) PIPELINE

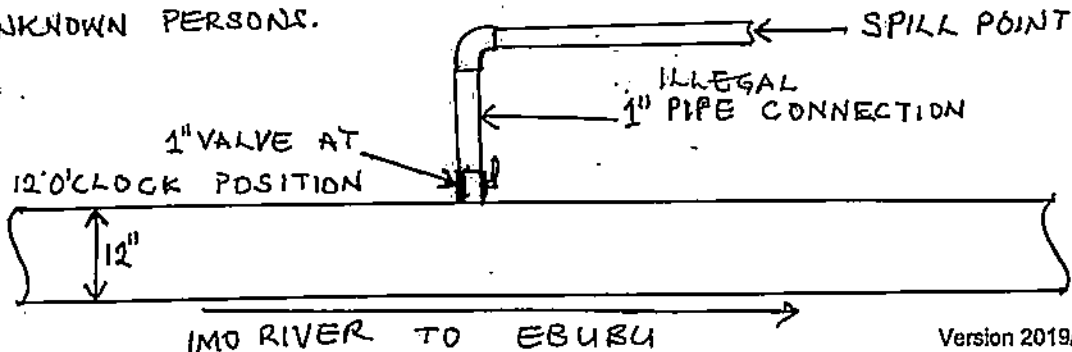
leak report, overview sketch of the site should be added as an appendix 1) A SECTION OF 12" IMO RIVER - EBUSU PIPELINE AT ISI ETITI OHA OWAZA, SHOWING ILLEGAL 1" VALVE CRUDE THEFT CONNECTION INSTALLED AT 12 O'CLOCK POSITION BY UNKNOWN PERSONS.

REPAIR BY CLAMPING
