JOINT INVESTIGATION REPORT

INCIDENT NO: 2552145 JIV report S/N: 1030228

1. Fountain Incident Number: 2552145 2. Type of incident* OIL SPILL
3. Name of Location 12" MORI-EBUBU TIL AT OGALE (PIPELINE)
4. Name of nearest community OGALE 5. State: RIVERS 6. LGA ELEME
7. Type of Production facility/Installation OIL PIPELINE
8. Asset owner/District THE SHELL PETROLEUM DEVELOPMENT COMPANY OF NIGERIA LIMITED (SPDC) / PIPELINE

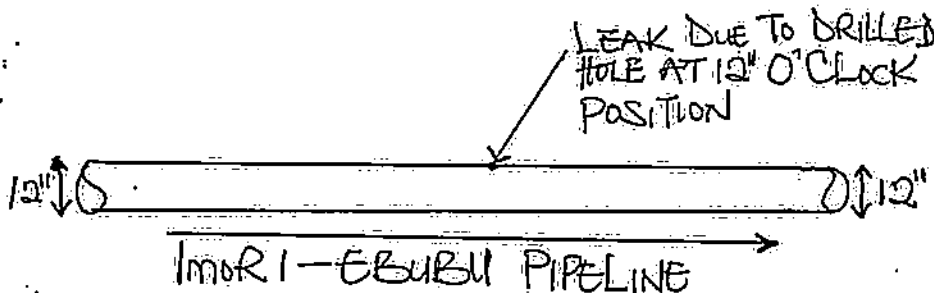
| <input checked="" type="checkbox"/> Drilled hole | <input type="checkbox"/> Hack saw cut | <input type="checkbox"/> Tear (_____) |

E. GRAPHIC DESCRIPTION OF LEAK POINT (while detail report of the leak point should be contained in the leak report, overview sketch of the site should be added as an appendix 1) A SECTION OF 12" IMOR RIVER I-EBURU PIPELINE AT OGALE SHOWING DRILLED HOLE AT 12 O'CLOCK POSITION UNKNOWN PERSON.

REPAIR WORK IN PROGRESS (CLAMPING)
