JOINT INVESTIGATION REPORT

INCIDENT NO: 2553181 JIV report S/N: 1030198

1. Fountain Incident Number: 2553181 2. Type of incident: OIL SPILL
3. Name of Location: 8" OBIGBO NORTH - NEW ELELENWA PIPELINE
4. Name of nearest community: UMUSONYA 5. State: RIVERS 6. LGA: OTIGBO
7. Type of Production facility/Installation: OIL PIPELINE
8. Asset owner/District: THE SHELL PETROLEUM DEVELOPMENT COMPANY OF NIGERIA LIMITED / PIPELINE

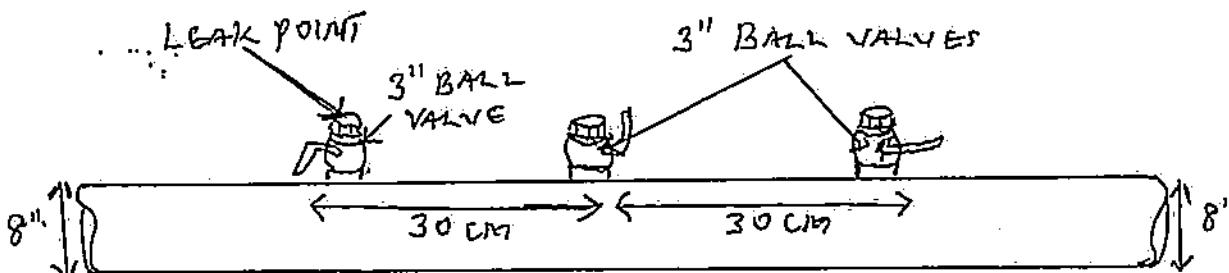
| <input checked="" type="checkbox"/> Failed Weld-on illegal hot tap valve | <input type="checkbox"/> Failed Clamp, | <input type="checkbox"/> Missing Pipeline/Flowline |
| <input checked="" type="checkbox"/> Crude oil theft (illegal bunkering) point, | <input type="checkbox"/> Saver-pit over flow | <input type="checkbox"/> Third party tampering with Clamp |

SECTION OF 8" OBIGBO NORTH - NEW ELELENWA PIPELINE AT UMUSONYA SHOWING THREE (3) NOS OF CRUDE OIL THEFT POINTS INSTALLED AT 12 O'CLOCK POSITION

RECOVERY AND REPAIR WORK ACTIVITIES ARE ONGOING
