JOINT INVESTIGATION REPORT

INCIDENT NO: 2559407 JIV report S/N: 1030230

1. Fountain Incident Number: 2559407 2. Type of incident* OIL SPILL
 3. Name of Location 20th NEW KOLOCREEK - RUMUGKPE PIPELINE
 4. Name of nearest community ORUMA 5. State: BAYELSA 6. LGA OGBIA
 7. Type of Production facility/Installation OIL PIPELINE
 8. Asset owner/District TITE SHELL PETROLEUM DEVELOPMENT COMPANY OF NIGERIA LIMITED (SPDC) / PIPELINE

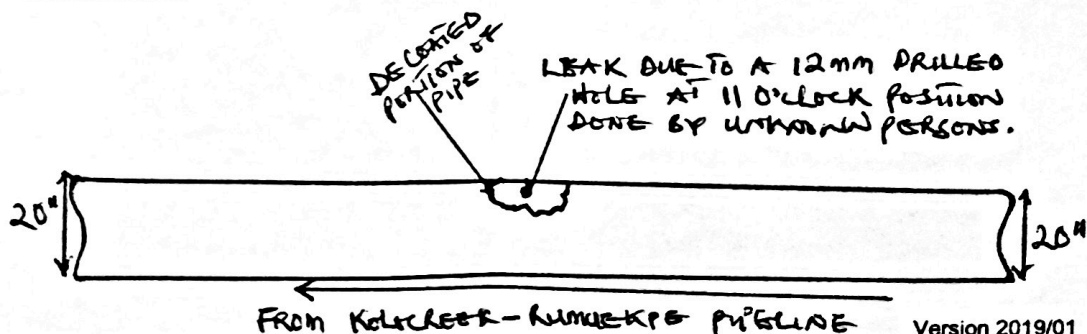
FROM KOLACREEK-RUMUEREKI PIPELINE

| <input checked="" type="checkbox"/> Drilled hole | <input type="checkbox"/> Hack saw cut | <input type="checkbox"/> Tear (_____). |

E. GRAPHIC DESCRIPTION OF LEAK POINT (while detail report of the leak point should be contained in the leak report, overview sketch of the site should be added as an appendix) A SECTION OF 20" KOLACREEK-RUMUEREKI PIPELINE AT ORUMA SHOWING A 12MM DRILLED HOLE AT 11 O'CLOCK POSITION DONE BY UNKNOWN PERSONS.
