# JOINT INVESTIGATION REPORT

INCIDENT NO: 2550157 JIV report S/N: 1030190

1. Fountain Incident Number: 2550157 2. Type of incident\* OIL SPILL  
3. Name of Location: 8" AGBADA 2-NKPOKU MANIFOLD D/L  
4. Name of nearest community ISHURUTA 5. State: RIVERS 6. LGA IKWERRE  
7. Type of Production facility/Installation OIL PIPELINE  
8. Asset owner/District THE SHELL PETROLEUM DEVELOPMENT COMPANY OF NIGERIA LIMITED (SPDC)/PIPELINE

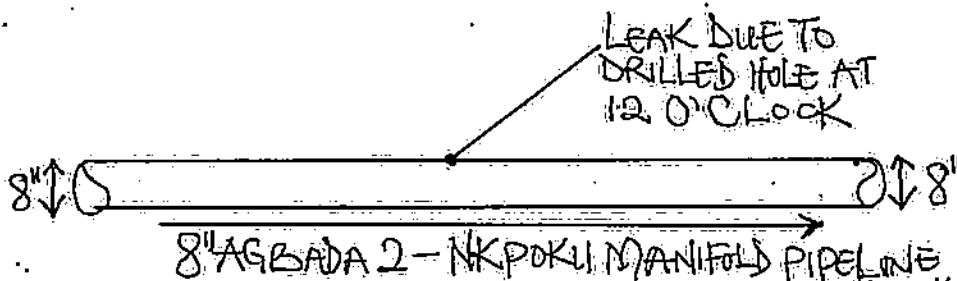
| <input checked="" type="checkbox"/> Drilled hole | <input type="checkbox"/> Hack saw cut | <input type="checkbox"/> Tear (_____) |

- Third party interference (Sabotage ; crude theft ; Line theft ; Accidental 3<sup>rd</sup> party damage   
 Operational  Others (including Mystery spills) \_\_\_\_\_

**E. GRAPHIC DESCRIPTION OF LEAK POINT** (while detail report of the leak point should be contained in the leak report, overview sketch of the site should be added as an appendix 1) A SECTION OF 8" AGBADA 2 - NKPOKU MANIFOLD PIPELINE AT IBWURUTA SHOWING DRILLED HOLE AT 12 O'CLOCK POSITION BY UNKNOWN PERSON(S)

CLAMPING/SPILL RESPONSE ONGOING  
NOT APPLICABLE

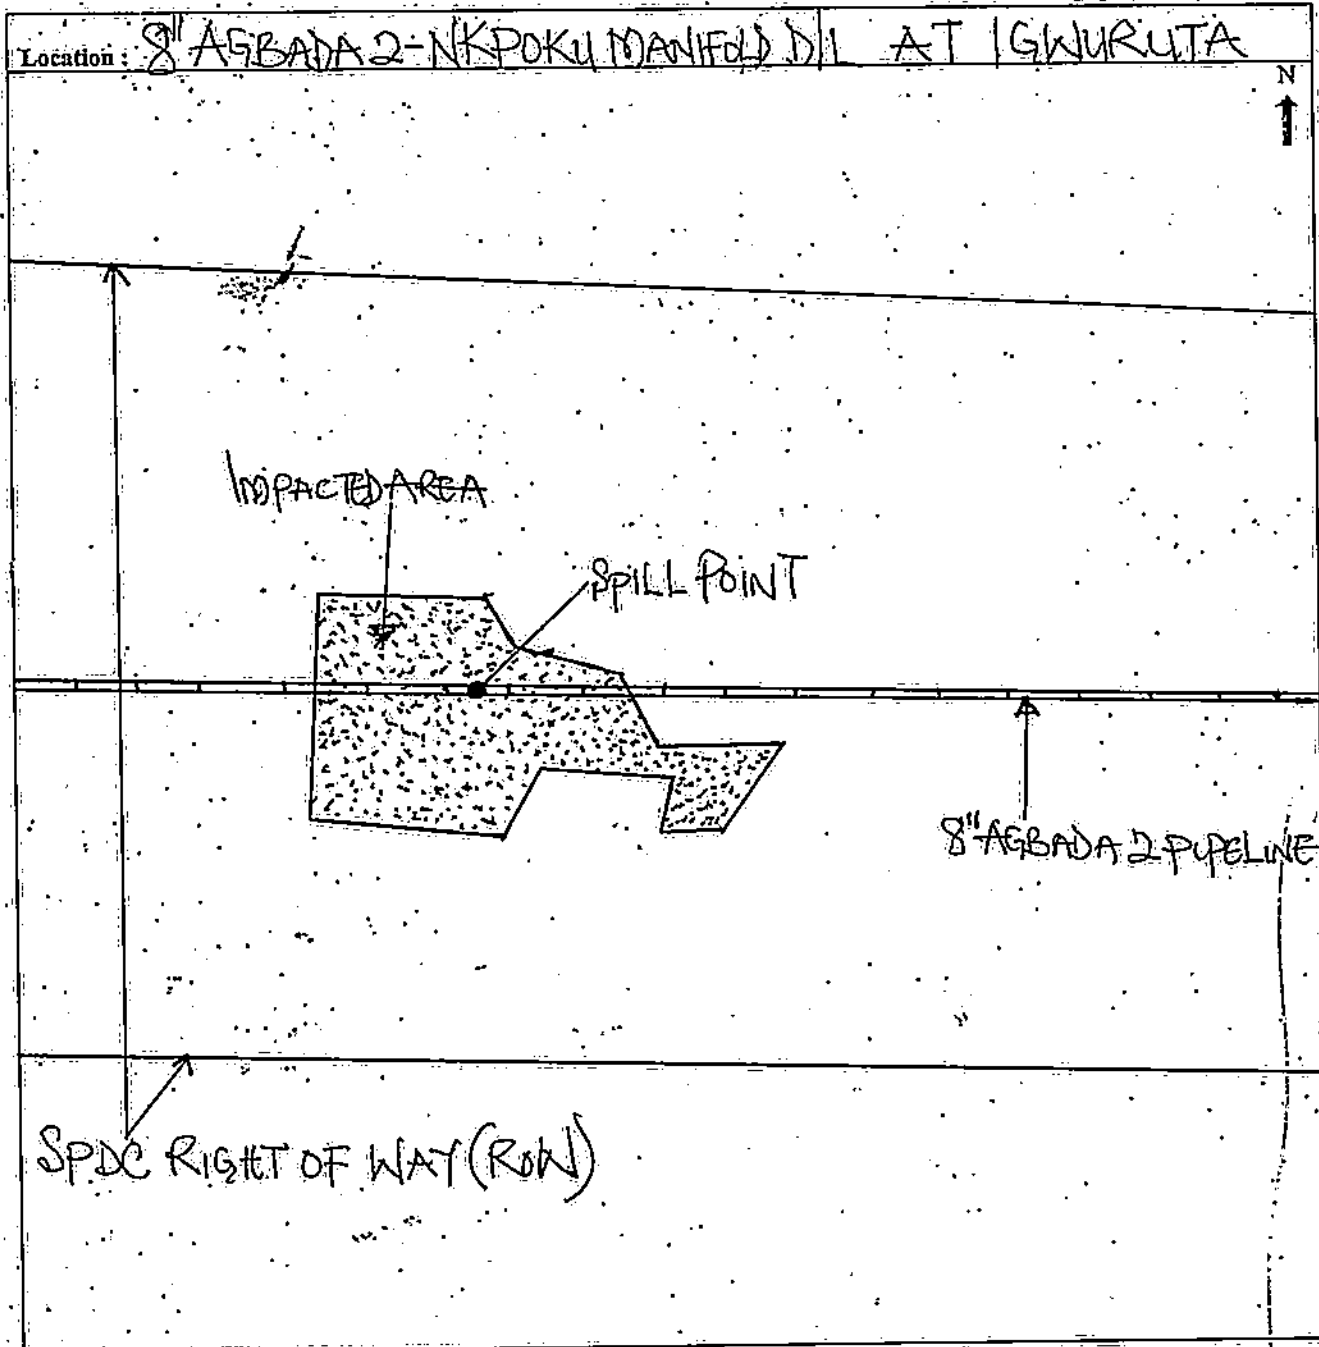
f. Appendix 1: Overview sketch of the site

- Total calculated area of impact: 0.038 Ha
- Impact within SPDC R.O.W: Yes
- Impact outside SPDC R.O.W: NO

| ii. Investigation of the incident site showed that there is residual impact on site requiring further works <input checked="" type="checkbox"/> |
