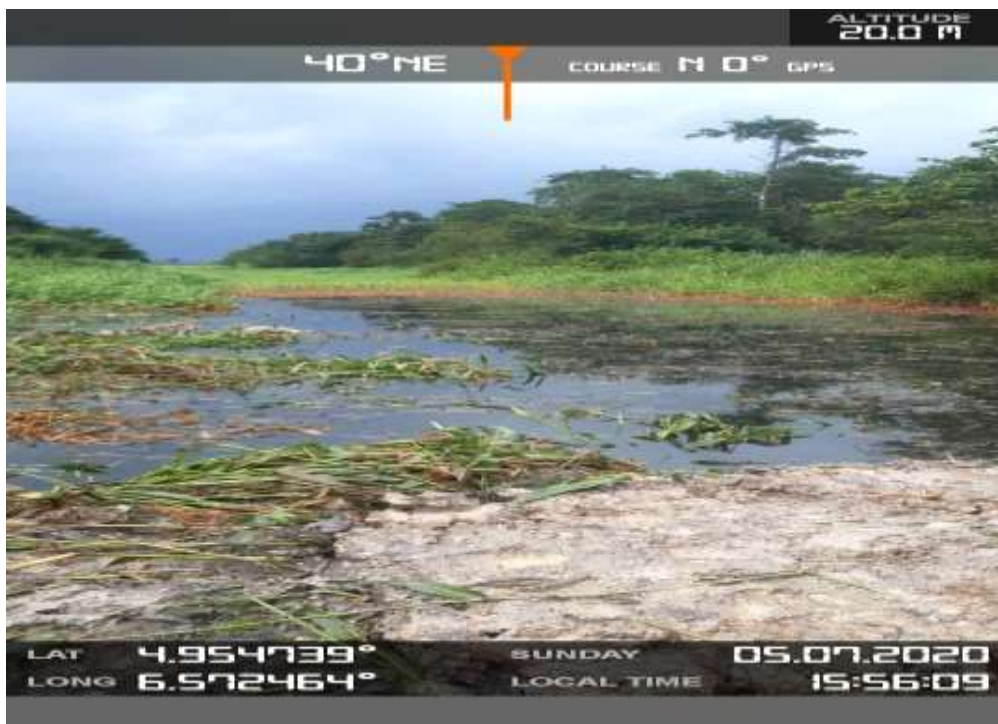
Overview: Part of spill impact on 20" Kolocreek – rumuekpe Pipeline at Owerewere . Picture was taken during Joint Investigation 5th July 2020.

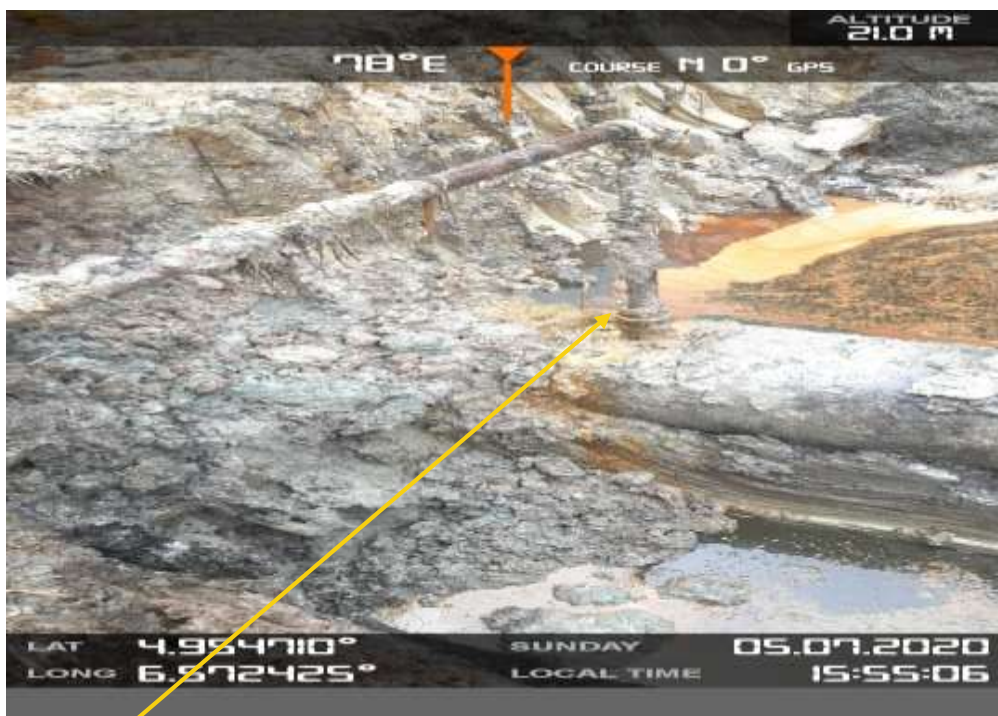
Close-up: Failed 3" Ball valve fittings installed at 12 o'clock position on 20" Kolocreek – rumuekpe Pipeline at Owerewere . Picture was taken during Joint Investigation 5th July 2020.
