JOINT INVESTIGATION REPORT

INCIDENT NO: 2679256 JIV report S/N:
0641

1. Fountain Incident Number: 2679256
2. Type of incident* OIL SPILL
3. Name of Location 20" KOLOCREEK - RUMNEKPE PIPELINE
4. Name of nearest community OWEREWERE
5. State Rivers
6. LGA OBIA - ONSAL
7. Production Facility/Installation OIL PIPELINE
8. Asset Owner/Hub THE SHELL PETROLEUM DEVELOPMENT COMPANY OF NIGERIA LIMITED PIPELINE

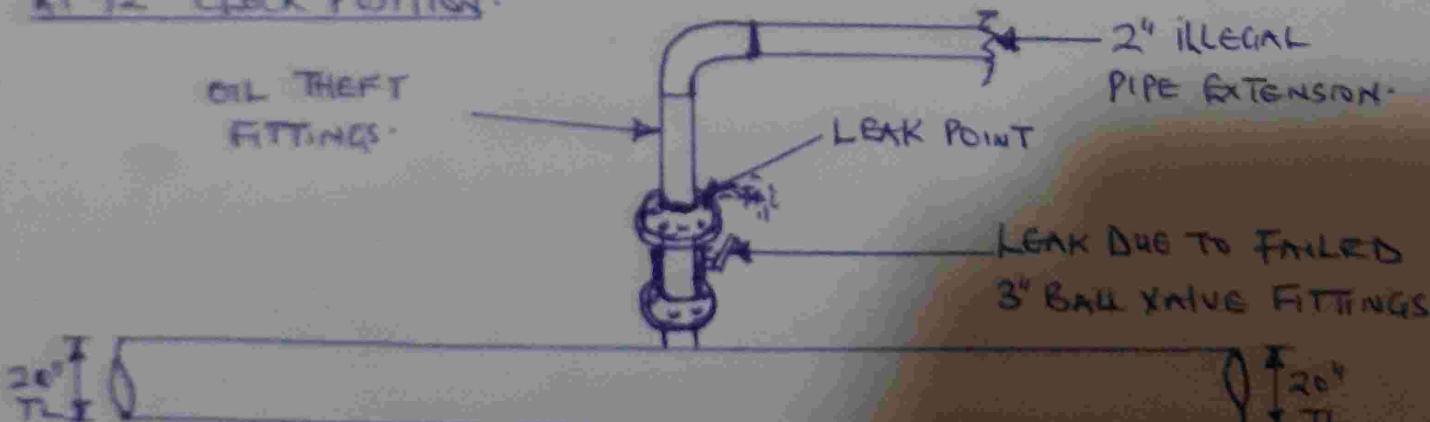
E. GRAPHIC DESCRIPTION OF LEAK POINT (while detailed description of the leak point should be contained in the leak report, overview sketch of the site should be added as appendix !)

| <input checked="" type="checkbox"/> Failed Weld-on illegal hot tap valve | <input type="checkbox"/> Failed Clamp | <input type="checkbox"/> Missing Pipeline/Flowline |
| <input checked="" type="checkbox"/> Crude oil theft (illegal bunkering) point, | <input type="checkbox"/> Saver-pit over flow | <input type="checkbox"/> Third party tampering with Clamp |

SECTIONAL VIEW OF 20" KOLDKREEK - RUMUREKE (TRUNKLINE) PIPELINE AT CHEGWENE SHOWING: FAILED 3" BALL VALVE FITTINGS INSTALLED AT 12° CLOCK POSITION.
