# JOINT INVESTIGATION REPORT

INCIDENT NO: 2681377 JIV report S/N: 0646

1. Fountain Incident Number: 2681377 2. Type of incident\* OIL SPILL  
3. Name of Location 18" ASA - RUMUEKPE PIPELINE  
4. Name of nearest community EGBEDA 5. State: RIVERS 6. LGA EMUOHA  
7. Production Facility/Installation OIL PIPELINE  
8. Asset Owner/Hub THE SHELL PETROLEUM DEVELOPMENT COMPANY OF NIGERIA LIMITED (SPDC)/ PIPELINE

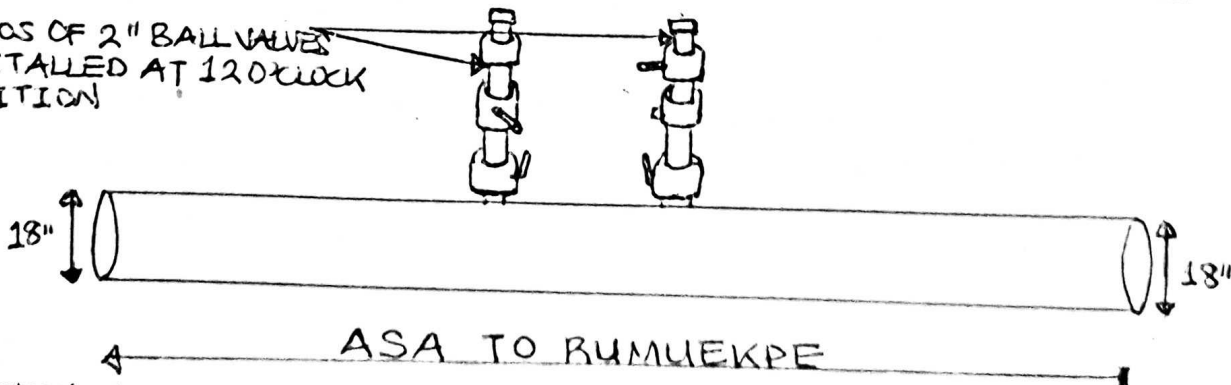
| <input checked="" type="checkbox"/> Crude oil theft (illegal bunkering) point, | <input type="checkbox"/> Saver-pit over flow | <input type="checkbox"/> Third party tampering with Clamp |

A SECTION OF 18" ASA - RUMUEKPE PIPELINE AT EGBEDA  
SHOWING 2 NOS OF 2" BALL VALVES INSTALLED AT A 12  
O'CLOCK POSITION BY UNKNOWN PERSON(S)

2 NOS OF 2" BALL VALVES  
 INSTALLED AT 12 O'CLOCK  
 POSITION

SPILL RESPONSE / REPAIRS BY CLAMPING
