JOINT INVESTIGATION REPORT

INCIDENT NO: 2678872 JIV report S/N:

1. Fountain Incident Number: 2678872 2. Type of incident* OIL SPILL
3. Name of Location 8" SEIBOU - AJATITON BULKLINE
4. Name of nearest community AGBIDIAMA 5. State: BAYELSA 6. LGA EKEREMO
7. Production Facility/Installation OIL BULKLINE
8. Asset Owner/Hub THE SHELL PETROLEUM DEVELOPMENT COMPANY NIGERIA LIMITED / TUNU NODE

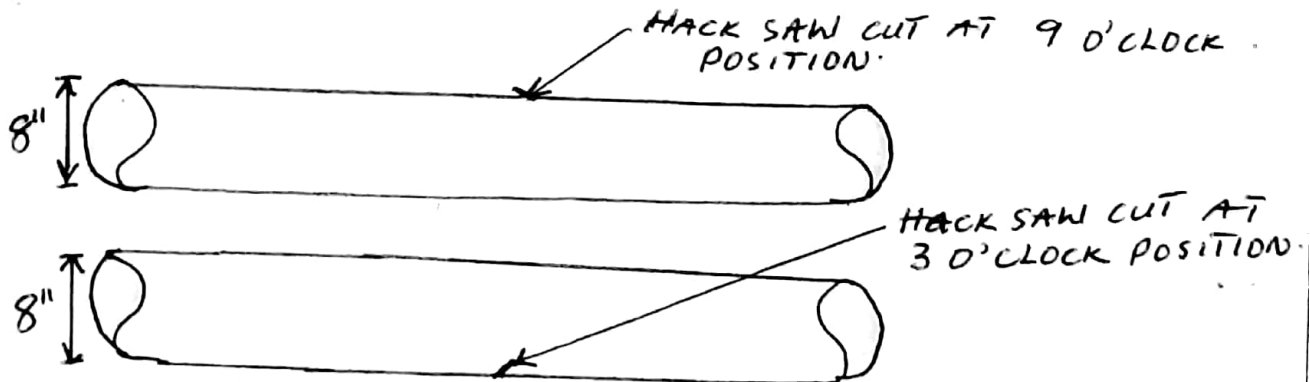
| <input type="checkbox"/> Smooth round-edge hole | <input type="checkbox"/> Rough-edge hole | <input checked="" type="checkbox"/> Hack saw cut |

A SECTION OF 8" SEIBOU - AJATITON BULKLINE AT AGBIDIAMA SHOWING 2 NO'S HACK SAW CUTS AT 3 O'CLOCK AND 9 O'CLOCK POSITIONS BY UNKNOWN PERSON.

REPAIR BY CLAMPING.
