INCIDENT NO: 2685062 JIV report S/N: 0647

A. GENERA	L INFORMATION:				
1. Fountain In	ncident Number: 268	5062	_ 2. Type of incid	dent* OIL SPILL	
3. Name of L	ocation 8" NK	ALI - C	GALEP	IPELINE

4. Name of no	earest community ODA	GWA_5. St	ate: RIVERS	6. LGA ETCHE	
7. Production	Facility/Installation	0	IL PIPEL	INE	
8. Asset Own B. INCIDEN	er/Hub THE SHEL OF NIGER TINFORMATION:	L PETRO	LEUM DEV	ELOPMENT COMPAN' PIPELINE	4

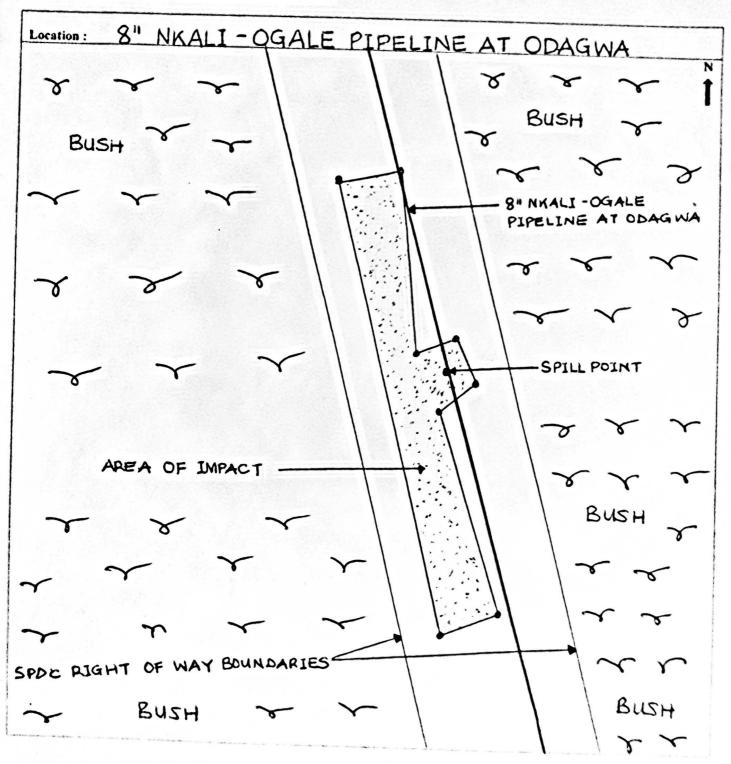
f. Appendix 1: Overview sketch of the site

20. Others (Specify) e.g. Animal Traps
S/N Others Description Quantity/Size Comments
MONE LITTUIN AREA OF IMPACT
GRAPHIC DESCRIPTION OF LEAK POINT (while detailed description of the leak point should be contained
the leak report, overview sketch of the site should be added as appendix 1) A SECTION OF 84 NKALL - CGALE PIPELINE AT ODAGWA
SHOWING 2 NOS OF 142 INCHES AND I INCH BALL VALVES
INSTALLED AT 120'CLOCK POSITION BY UNKNOWN PERSONCS)
2 NOS OF 1 1/2 INCHES AND 1 INCH BALL VALVES INSTALLED AT 12 DECIDENT
YALVES INSTALLED AT 12 O'CLOCK
8" 8"
8" NKALI FO OGALE PIPELINE
