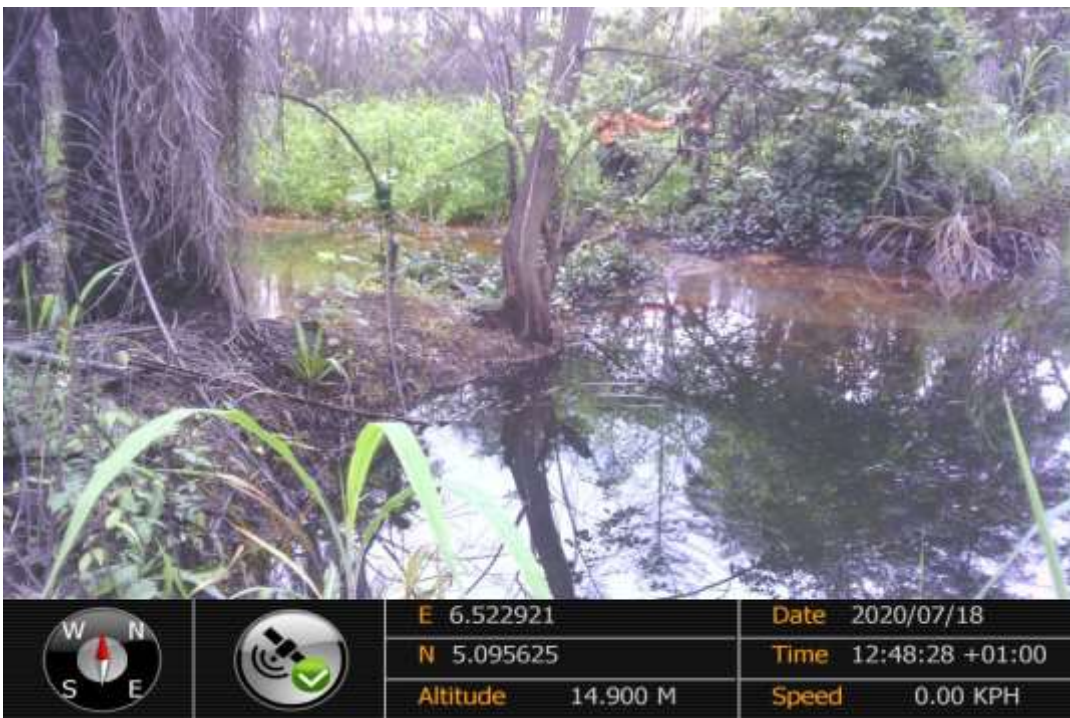
Overview: Part of spill impact on 14" Okordia Rumuekpe Pipeline at Idu-Ekpeye .  
Picture was taken during Joint Investigation 18th July 2020.

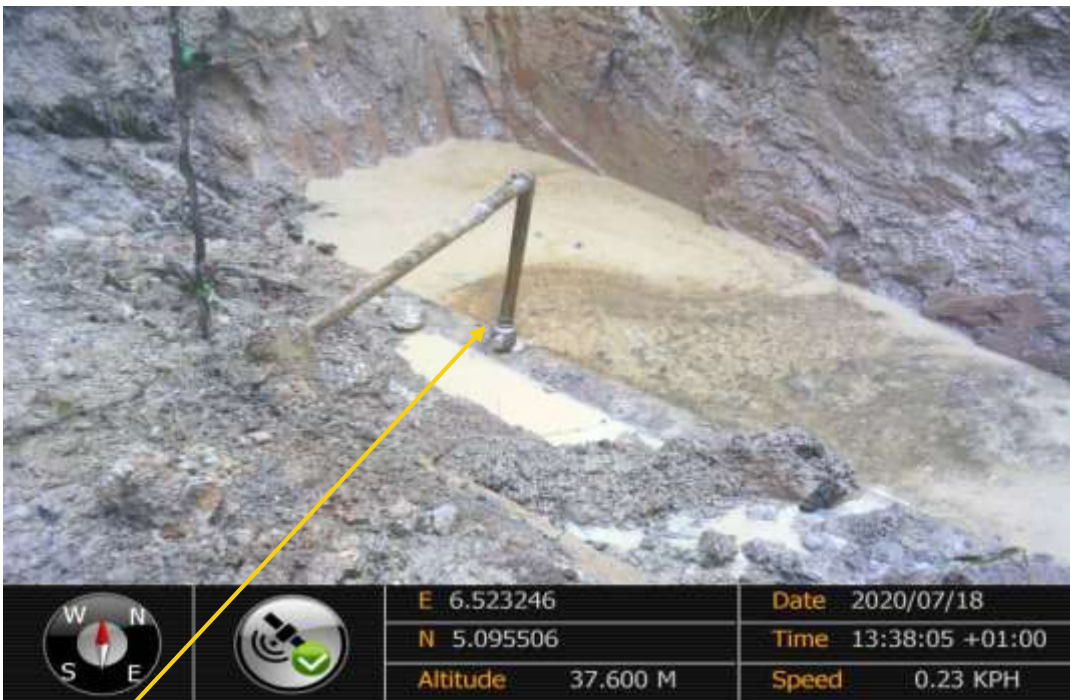
Close-up: Failed 2inch ball valve fittings installed at 12 o'clock position on 14" Okordia Rumuekpe Pipeline at Idu-Ekpeye . Picture was taken during Joint Investigation 18th July 2020.
