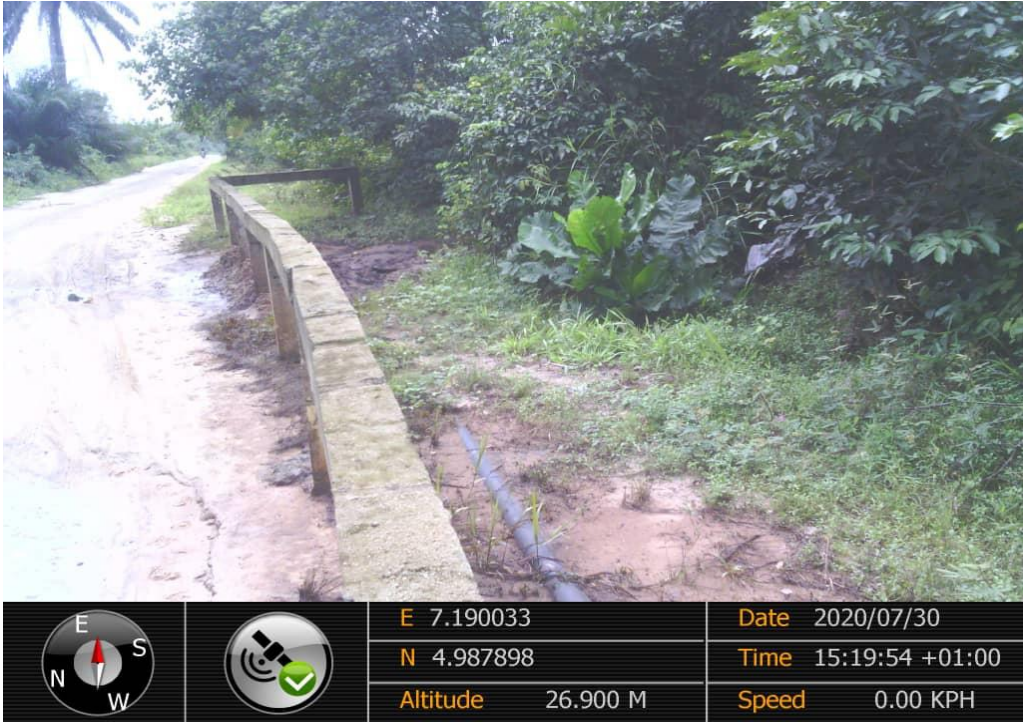
**Overview:** Part of spill impact on 4" Imo River Well 32L Flowline at Igiriukwu-Owaza. Picture was taken during Joint Investigation of 30<sup>th</sup> July 2020.

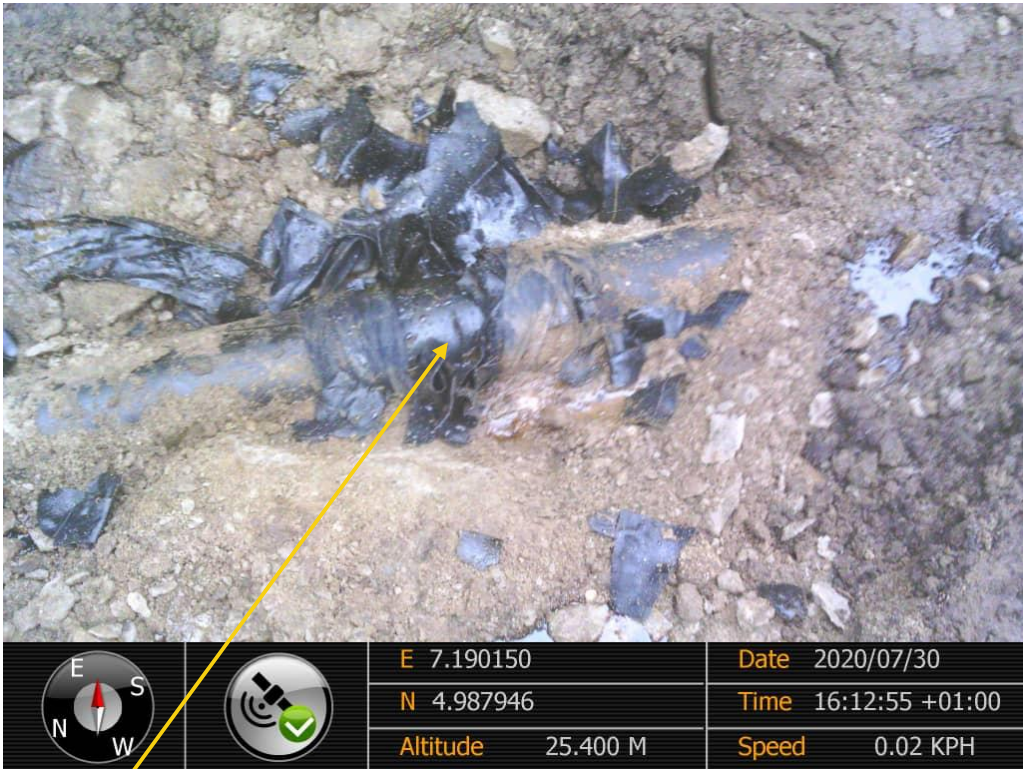
**Close-up:** Hack Saw Cut on 4" Imo River Well 32L Flowline at Igiriukwu-Owaza. Picture was taken during Joint Investigation of 30<sup>th</sup> July 2020.
