# JOINT INVESTIGATION REPORT

INCIDENT NO: 2698365 JIV report S/N:

1. Fountain Incident Number: 2698365 2. Type of incident\* OIL SPILL  
3. Name of Location 14<sup>th</sup> OKORDIA - RUMUKPE PIPELINE  
4. Name of nearest community EDEOHA 5. State: RIVERS 6. LGA AHOADA-EAST  
7. Production Facility/Installation OIL PIPELINE  
8. Asset Owner/Hub THE SHELL PETROLEUM DEVELOPMENT COMPANY OF NIGERIA LIMITED (SPDC)/PIPELINE

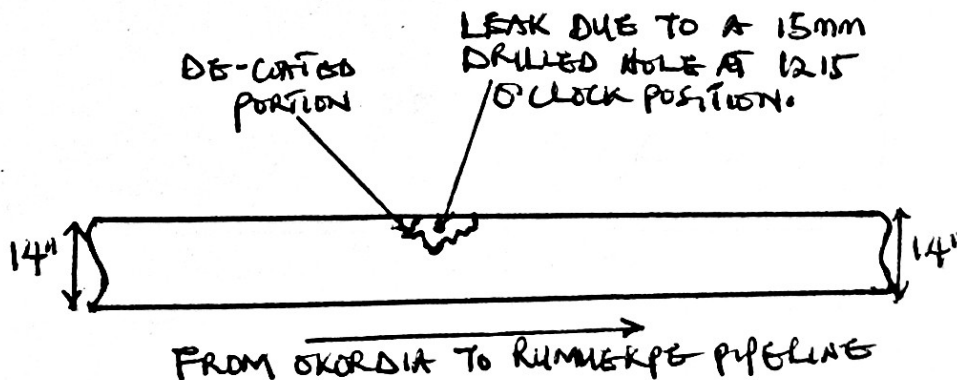
Additional observations around the spill point: DE-CORATED PORTION OF THE PIPELINE WAS OBSERVED BY THE JOINT INVESTIGATION TEAM AROUND THE SPILL POINT.

**E. GRAPHIC DESCRIPTION OF LEAK POINT** (while detailed description of the leak point should be contained in the leak report, overview sketch of the site should be added as appendix 1) A SECTION OF 14" OKORDIA-RUMUKEPE PIPELINE AT EDEGHA SHOWING A 15mm DRILLED HOLE AT 1215 O'CLOCK POSITION DONE BY UNKNOWN PERSONS.
