JOINT INVESTIGATION REPORT

INCIDENT NO: 2695749 JIV report S/N: 0727

1. Fountain Incident Number: 2695749 2. Type of incident: CRUDE OIL SPILL
3. Name of Location: 24" TRANS ESCRAVOS PIPELINE
4. Name of nearest community: OGIDIGBENS State: DELTA 6. LGA: WARRI SOUTH WEST
7. Production Facility/Installation: CRUDE OIL PIPELINE
8. Asset Owner/Hub: THE SHELL PETROLEUM DEVELOPMENT COMPANY NIGERIA LIMITED / PIPELINE

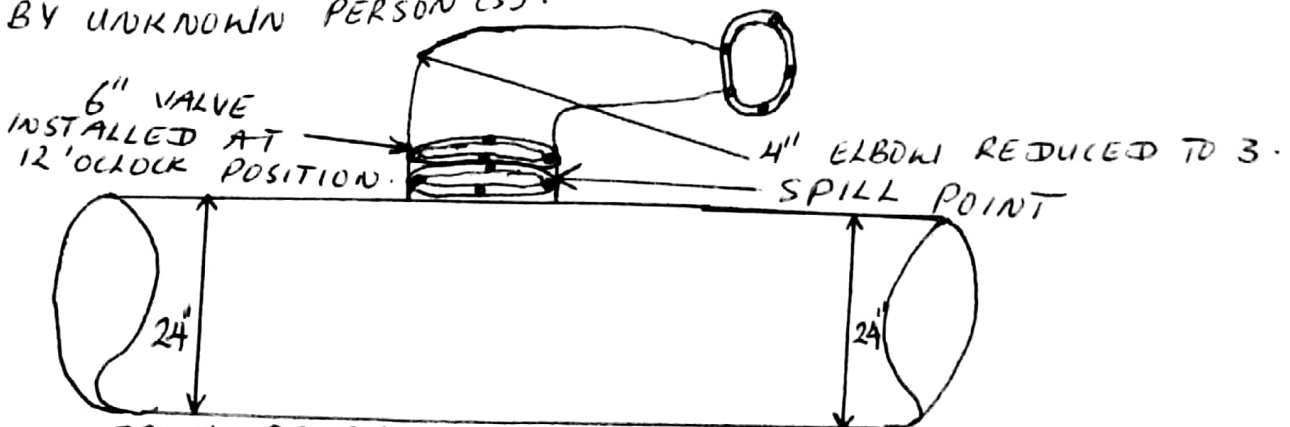
E. GRAPHIC DESCRIPTION OF LEAK POINT (while detailed description of the leak point should be contained in the leak report, overview sketch of the site should be added as appendix 1)

A SECTION OF 24" TRANS ESCRAVDS PIPELINE AT OGI DIGBEN SHOWING WELD-ON 6" VALVE INSTALLED AT 12 O'CLOCK POSITION BY UNKNOWN PERSON (S).
