# JOINT INVESTIGATION REPORT

INCIDENT NO: 2664852 JIV report S/N: 0548

1. Fountain Incident Number: 2664852 2. Type of incident\* OIL SPILL  
3. Name of Location 14" OKORDIA - RUMUKEPE PIPELINE  
4. Name of nearest community EDEOHA 5. State: RIVERS 6. LGA AHOADA EAST  
7. Production Facility/Installation CRUDE OIL PIPELINE  
8. Asset Owner/Hub THE SHELL PETROLEUM DEVELOPMENT COMPANY  
OF NIGERIA LIMITED / PIPELINE

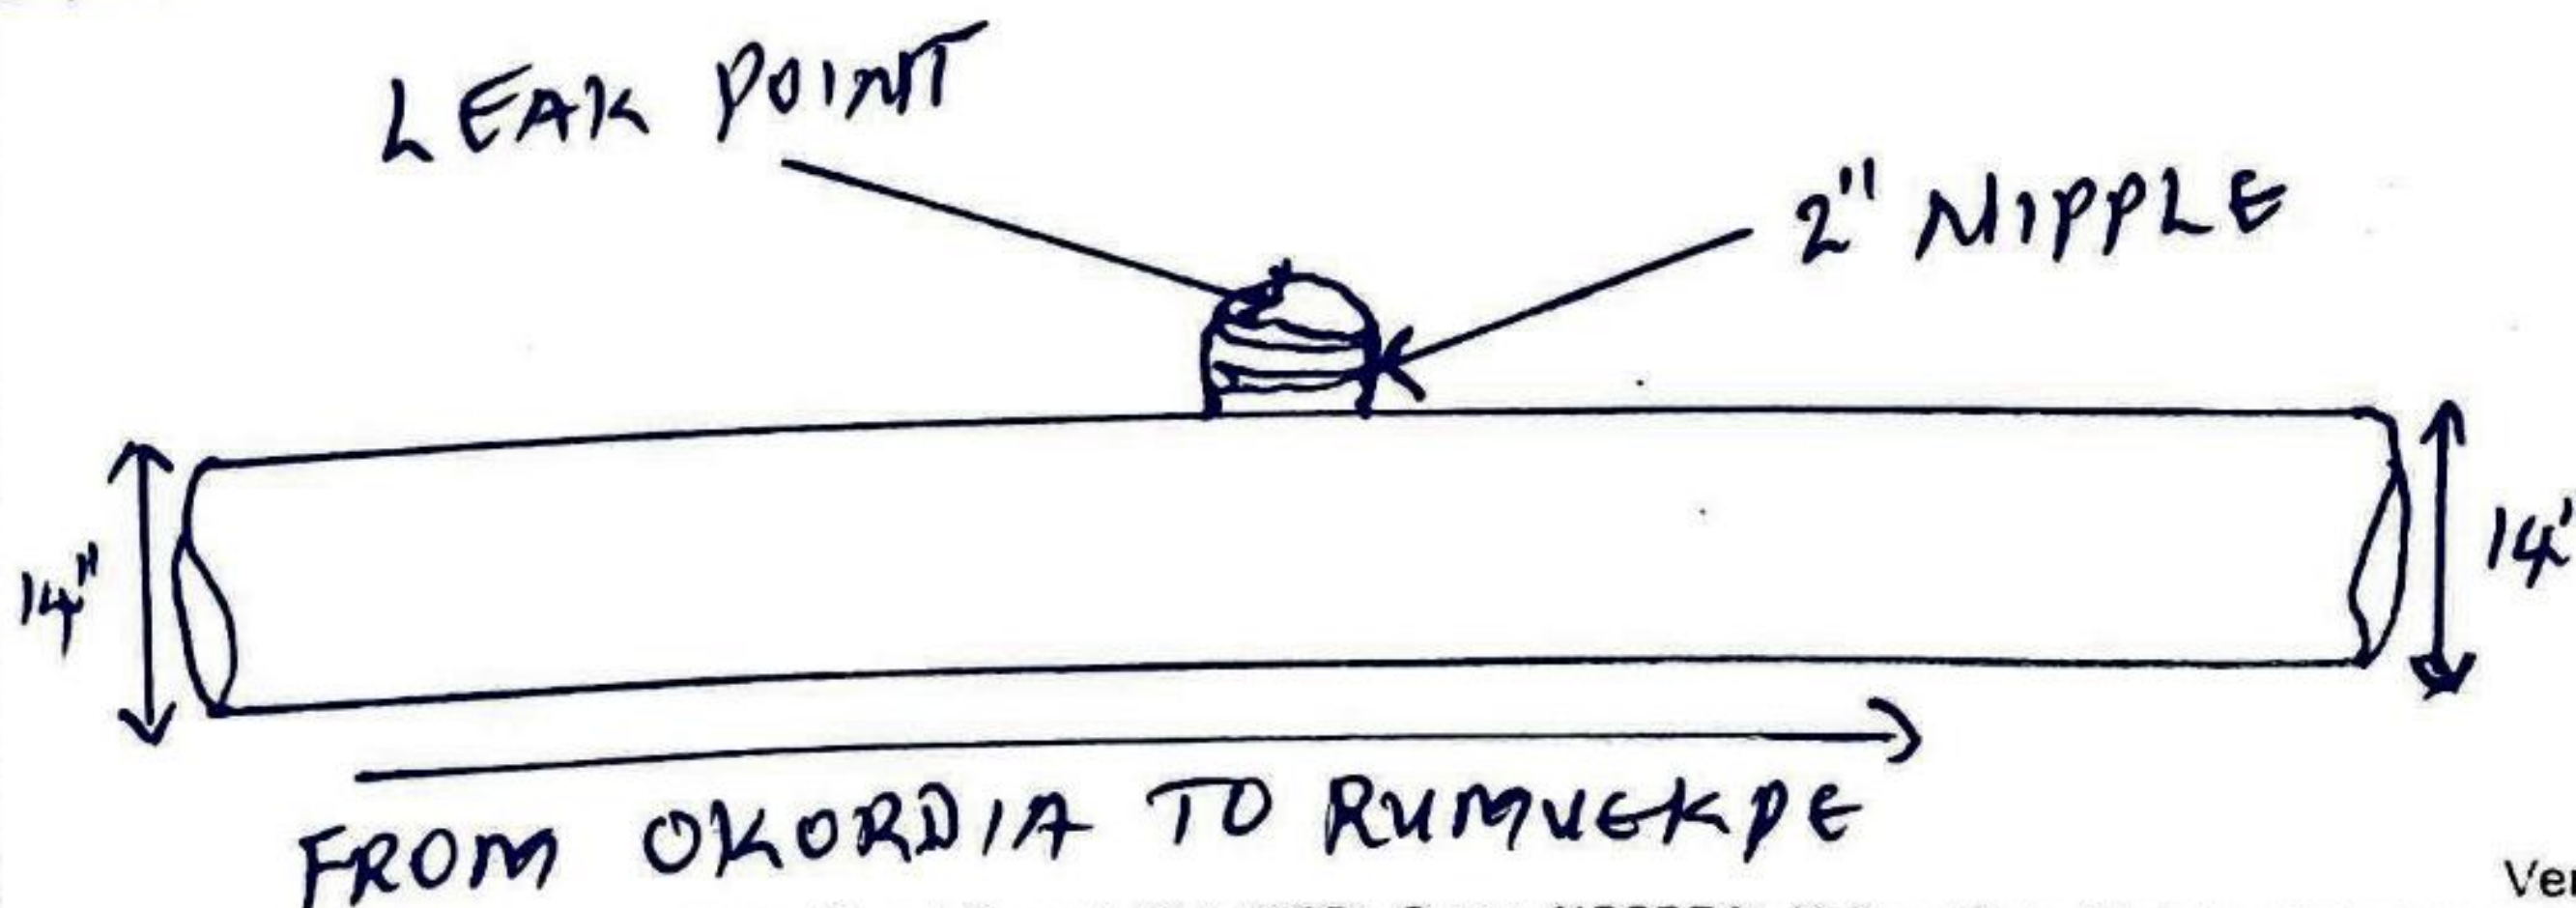
| <input checked="" type="checkbox"/> Failed Weld-on illegal hot tap valve | <input type="checkbox"/> Failed Clamp, | <input type="checkbox"/> Missing Pipeline/Flowline |
| <input checked="" type="checkbox"/> Crude oil theft (illegal bunkering) point, | <input type="checkbox"/> Saver-pit over flow | <input type="checkbox"/> Third party tampering with <b>Clamp</b> |

SECTION OF 14" OKORDIA - RUMUEKPE PIPELINE AT EDEOMA SHOWING CRUDE OIL LEAK POINT INSTALLED AT 12 O' CLOCK POSITION BY UNKNOWN PERSONS.

REPAIR ACTIVITY ONGOING.
