# JOINT INVESTIGATION REPORT

INCIDENT NO: 2658923 JIV report S/N:

1. Fountain Incident Number: 2658923 2. Type of incident\* OIL SPILL  
3. Name of Location 14" OKORDIA - RUMUEKPE PIPELINE  
4. Name of nearest community EDEOHA 5. State: RIVERS 6. LGA AHOADA EAST  
7. Production Facility/Installation OIL PIPELINE  
8. Asset Owner/Hub THE SHELL PETROLEUM DEVELOPMENT COMPANY  
OF NIGERIA LIMITED / PIPELINE

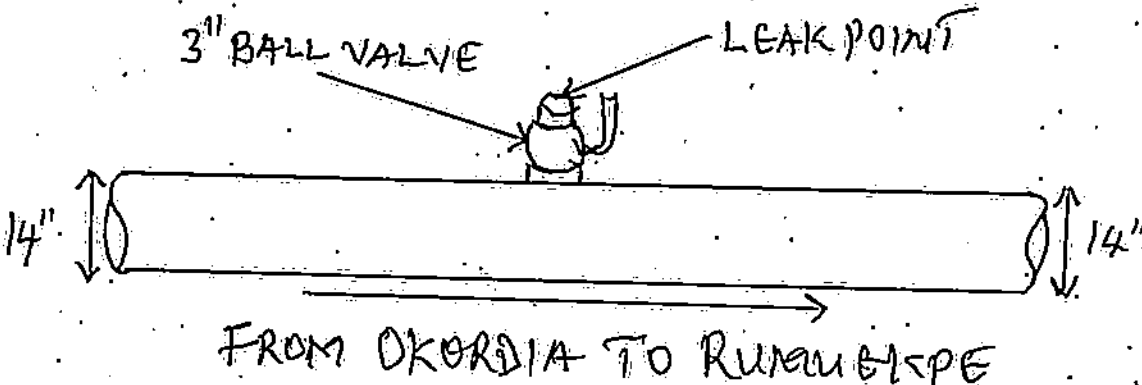
**E. GRAPHIC DESCRIPTION OF LEAK POINT** (while detailed description of the leak point should be contained in the leak report, overview sketch of the site should be added as appendix 1)

| <input checked="" type="checkbox"/> Failed Weld-on illegal hot tap valve | <input type="checkbox"/> Failed Clamp, | <input type="checkbox"/> Missing Pipeline/Flowline |
| <input checked="" type="checkbox"/> Crude oil theft (illegal bunkering) point, | <input type="checkbox"/> Saver-pit over flow | <input type="checkbox"/> Third party tampering with Clamp |

SECTION OF 14" OKORDIA - RUMUBIKPE PIPELINE AT GDEGHA SHOWING CRUDE OIL THEFT POINT INSTALLED AT 12 O'CLOCK POSITION BY UNKNOWN PERSONS.

REPAIR WAS DONE BY CLAMPING, RECOVERY  
ACTIVITIES ARE ONGOING.
