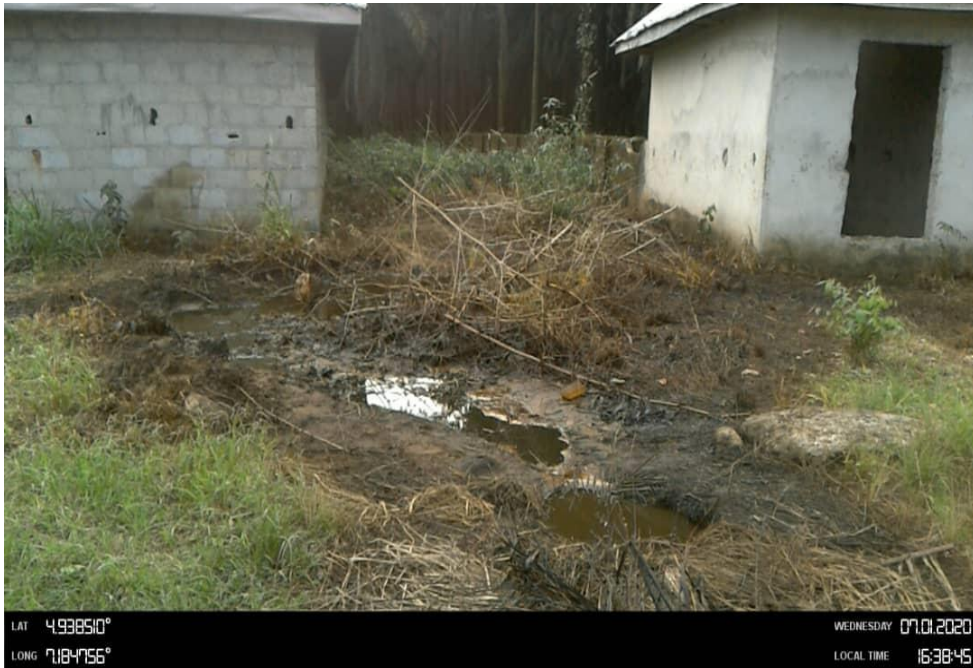
Overview: Part of spill impact on 12" ImoRiver - Ogale Pipeline at Umulolo. Picture was taken during Joint Investigation 1st July 2020.

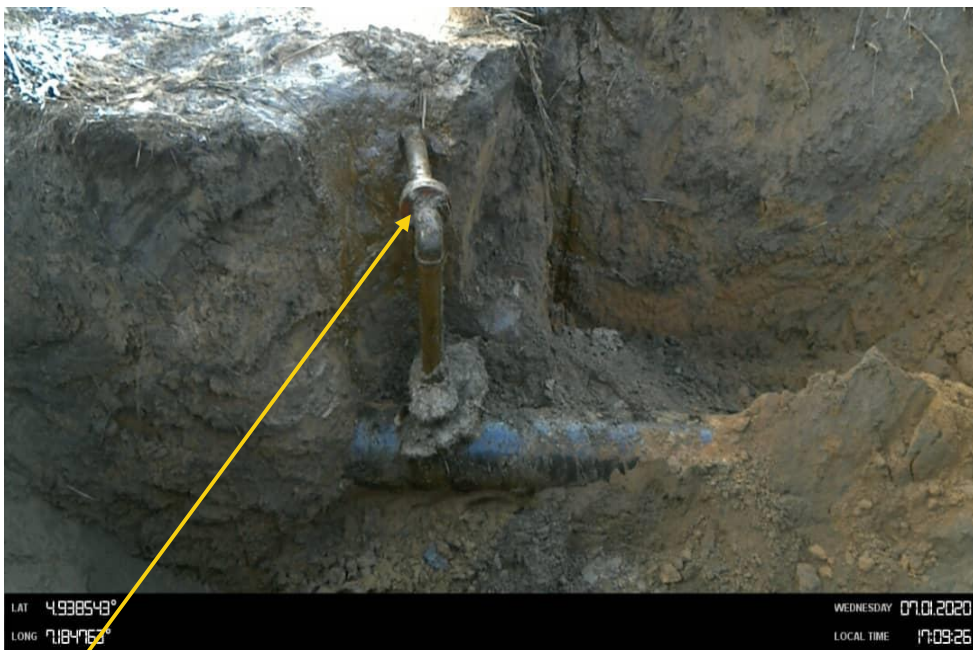
Close-up: 3" ball valve installed with elbow at 12 o'clock to 3 o'clock position on 12" Imo River - Ogale Pipeline at Umulolo. Picture was taken during Joint Investigation 1st July 2020.
