JOINT INVESTIGATION REPORT

INCIDENT NO: 2677135 JIV report S/N: 0631

1. Fountain Incident Number: 2677135 2. Type of incident* OIL SPILL
3. Name of Location 12" IMO RIVER - OGALE PIPELINE
4. Name of nearest community UMUOLOLO 5. State: ABIA 6. LGA UKWA WEST
7. Production Facility/Installation OIL PIPELINE
8. Asset Owner/Hub THE SHELL PETROLEUM DEVELOPMENT COMPANY OF NIGERIA LIMITED(SPOC)/ PIPELINE

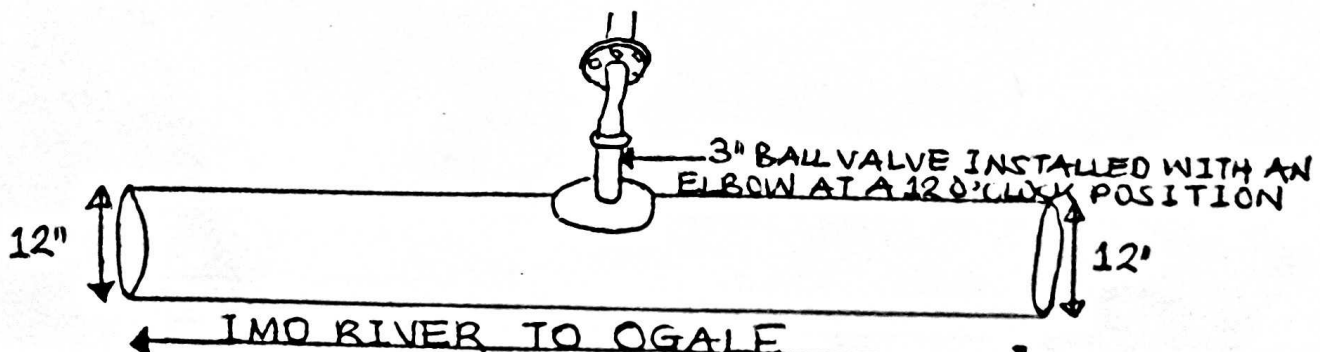
| <input checked="" type="checkbox"/> Crude oil theft (illegal bunkering) point, | <input type="checkbox"/> Saver-pit over flow | <input type="checkbox"/> Third party tampering with Clamp |

A SECTION OF 12" IMR RIVER - OGALE PIPELINE AT UMUOLOLO SHOWING A 3" BALL VALVE INSTALLED WITH AN ELBOW AT A 12 O'CLOCK POSITION BY UNKNOWN PERSON(S)

REPAIRS BY CLAMPING
