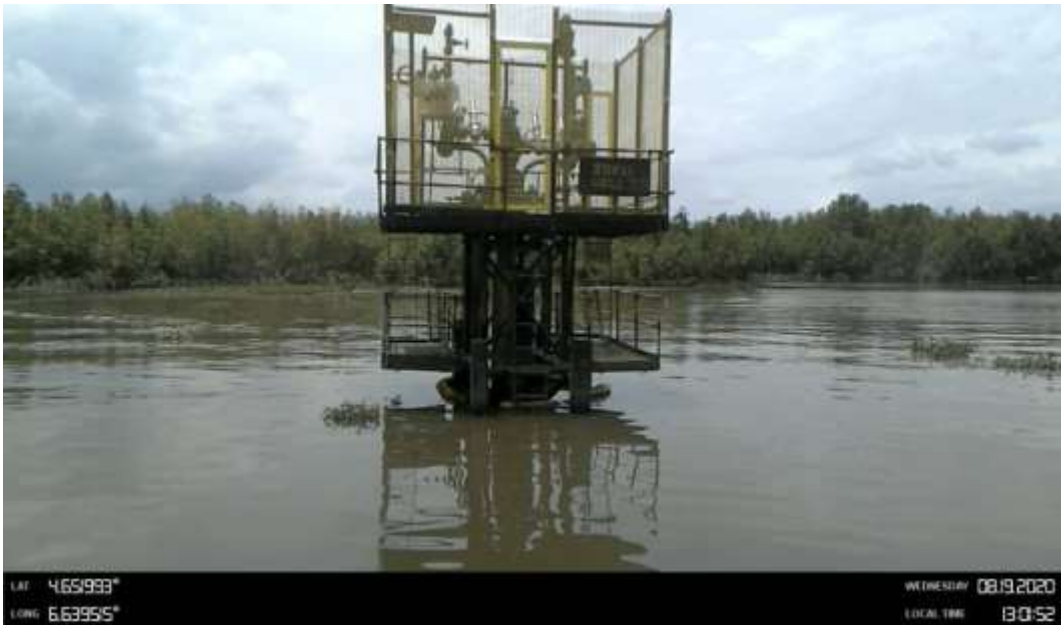
Overview: Part of spill impact on 4" Soku Well 23 Flowline at Ekineama 2. Picture was taken during Joint Investigation on 19th August 2020.

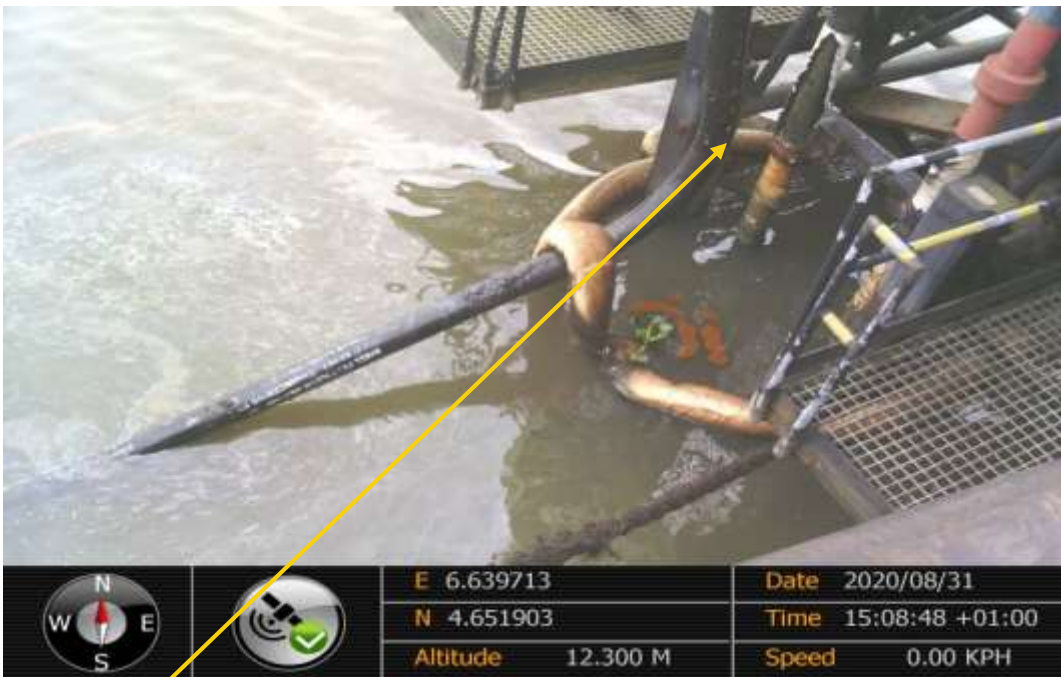
Close-up: Corrosion at 6 o'clock position on 4" Soku Well 23 Flowline at Ekineama 2. Picture was taken during Joint Investigation on 31st August 2020.
